Mercedes-Benz

Campaign No. 2015030005, March 2015

SUBJECT: **Model 218 (CLS-Class), Model Year 2012-2015**
Rear Side Marker Lamps, SCN Code the Rear SAM

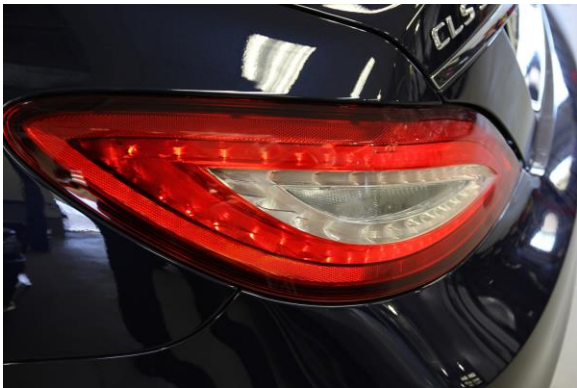
This Recall Campaign has been initiated because Daimler AG (DAG), the manufacturer of Mercedes-Benz vehicles, has determined that the rear side marker lamps may not illuminate according to specifications and so the vehicles might not meet the requirements of Federal Motor Vehicle Safety Standard (FMVSS) number 108, "Lamps, reflective devices and associated equipment." The illumination level might be below the required level due to a software coding issue which leads to the non-activation of certain LEDs. Insufficient illumination levels in certain measuring points of the rear side marker function may reduce vehicle visibility for lateral traffic and could increase the risk of a crash. To correct this condition an authorized Mercedes-Benz dealer will SCN code the rear SAM.

Rear parking lamps will be illuminated prior to SCN coding of the rear SAM (with parking lamps or head lamps **ON**). However, the rear side marker lamp (arrow, Figure 2) will **not** be illuminated (Figure 1).

Figure 1 (without side marker lamp illuminated)

1. Perform SCN coding in rear SAM control module:
Control units view / SAM-H (rear signal acquisition and actuation module) / Control unit adaptations / Configuration / SCN coding.
2. Follow on-screen instructions.

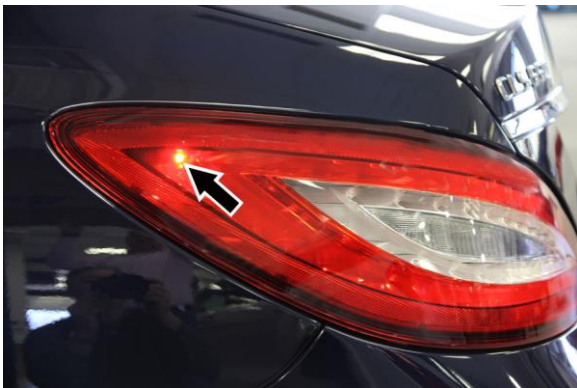
After SCN coding is complete rear side marker lamp (arrow). **will be** illuminated

Figure 2 (with side marker lamp illuminated)
