Bulletin No.: 15168A
Date: May 2015

Recall Bulletin

SUBJECT: Loss of Electric Power Steering Assist

MODELS: 2015 Buick Encore
2015 Chevrolet Trax

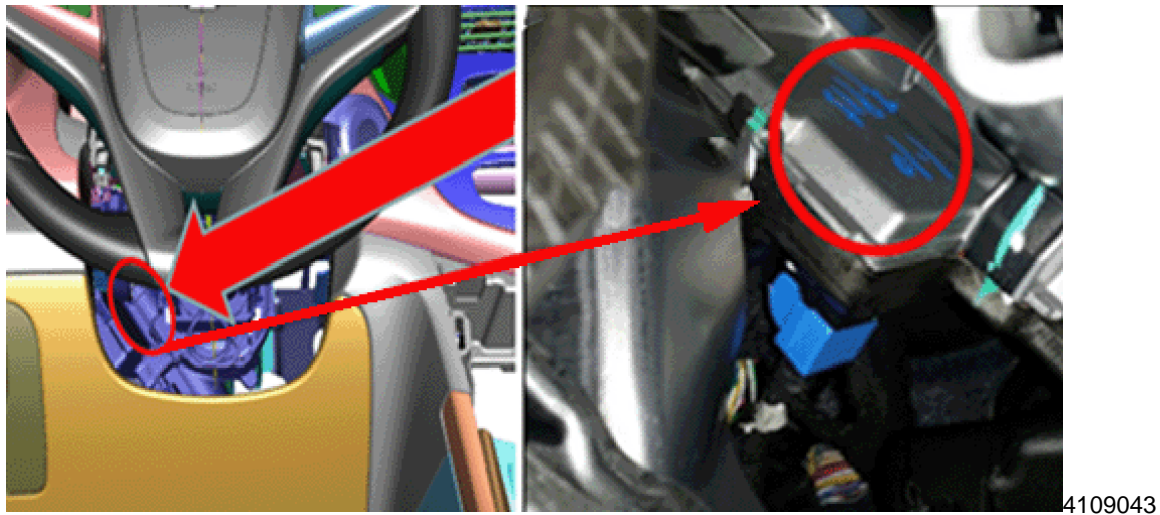
Location of steering column lot number

8. Check the housing LOT number.

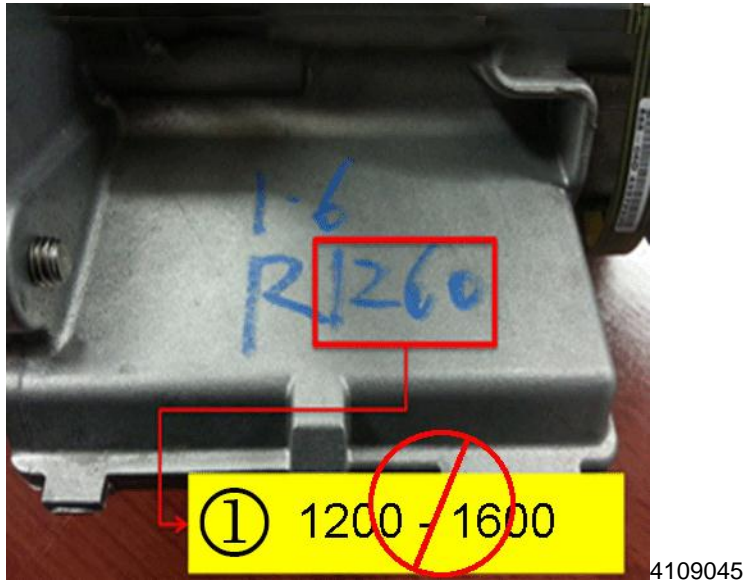
NOTE: If the LOT number is illegible, or not readable, replace steering column.

- 9. A part with a LOT number (1) above 1200 (**including 1200, and up to and including 1600**) is **not OK** and must be replaced with a new steering column.
- 10. **If the LOT number is 1199 or less, then the part is OK** and the steering column does not need to be replaced. Do not go to the next step. Re-assemble parts in reverse order.
- 11. If the steering column has failed inspection, it will be necessary to replace the column. Refer to *Steering Column Replacement* in SI.
