Bulletin No.: 15168  
Date: March 2015

# Recall Bulletin

**SUBJECT:** Loss of Electric Power Steering Assist

**MODELS:** 2015 Buick Encore  
2015 Chevrolet Trax

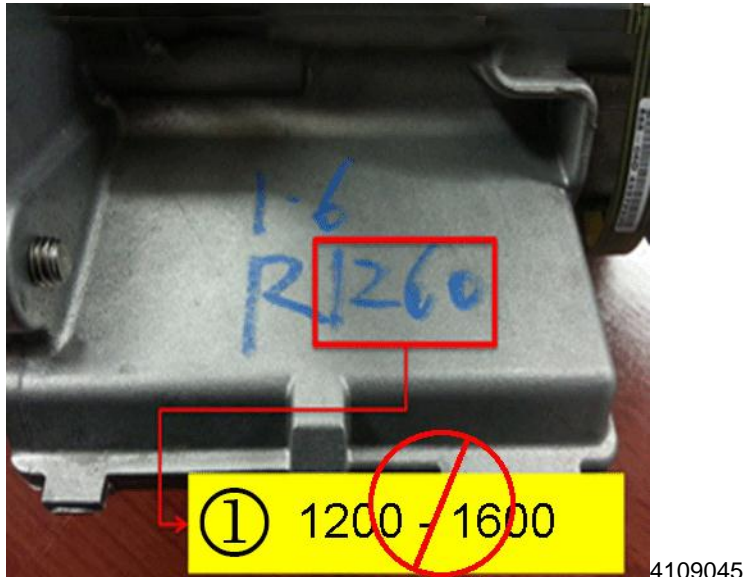
9. A part with a LOT number (1) above 1200 (**including 1200, and up to and including 1600**) is **not OK** and must be replaced with a new steering column.
10. **If the LOT number is 1199 or less, then the part is OK** and the steering column does not need to be replaced. Do not go to the next step. Re-assemble parts in reverse order.
11. If the steering column has failed inspection, it will be necessary to replace the column. Refer to *Steering Column Replacement* in SI.

**NOTE:** If the LOT number is illegible, or not readable, replace steering column.
