NEW **Recall Campaign: Reprogram Advanced Crash Safety Module**

F33 (4 Series Convertible)

Produced from November 1, 2014 to February 27, 2015

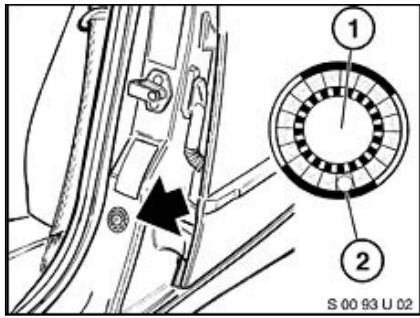
<p>This Recall Campaign has been assigned code number 733. After the vehicle has been checked and/or corrected, obtain a label (SD 92-464) and:</p> <ol style="list-style-type: none"> Emboss your BMW center warranty number in the middle of the label (1); Punch out code number 733 (2), printed on the label; and Affix the label to the B-pillar as shown.
---	--

If the vehicle already has a label from a previous Service Action/Recall Campaign, affix the new label next to the old one. Do not affix one label on top of another one, because a number from an underlying label could appear in the punched-out hole of the new label.
