# Recall Bulletin

**SUBJECT:** Misalignment of Driver Airbag Inflator

**MODELS:** 2015 Chevrolet Colorado  
2015 GMC Canyon

GM Recall #15037

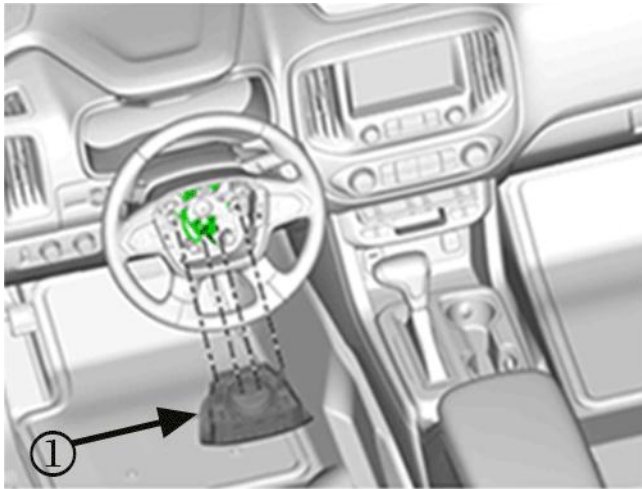
4112192

1. Remove the steering wheel airbag module (1). Refer to *Steering Wheel Airbag Replacement* in SI.
2. Viewing the back side of the airbag module, inspect the orientation of the airbag inflator module in reference to the housing back plate.

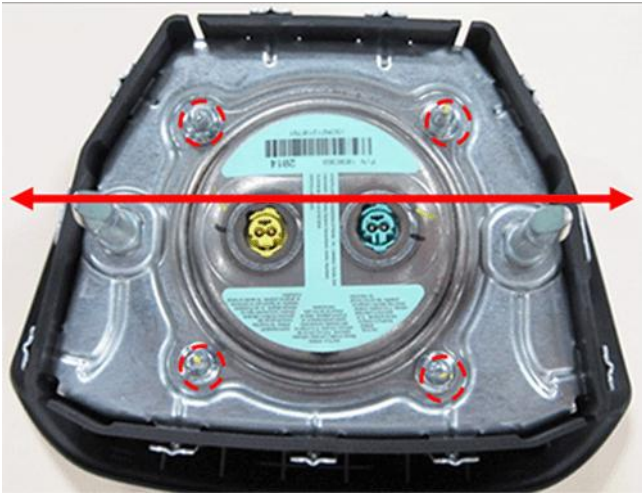
4112183

- If the inflator is centered horizontally and all the retaining flanges are engaged to the retaining studs, no further action is required. Reinstall the airbag module, refer to *Steering Wheel Airbag Replacement* in SI.

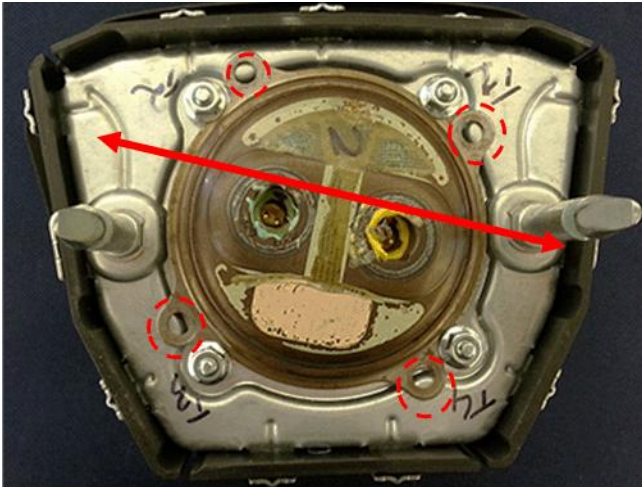
4112187

- If the inflator is rotated off-center and none of the retaining flanges are engaged to the retaining studs, replacement of the steering wheel airbag assembly is required. Move ahead to *Steering Wheel Airbag Replacement* below.

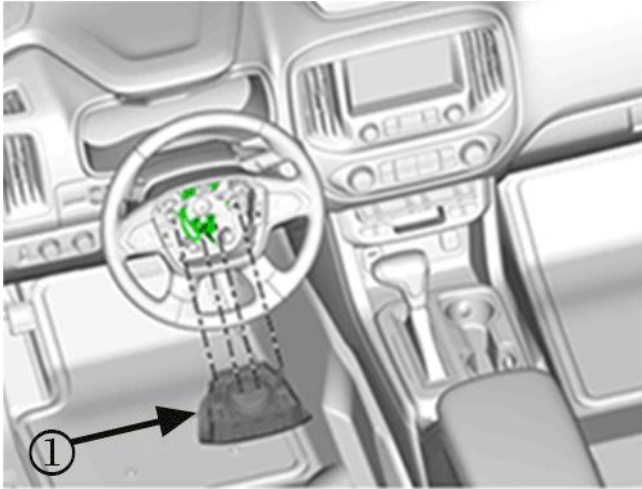
**Warning:** The removed steering wheel airbag modules that are the subject of this recall **MUST NOT** be deployed. It is possible that the inflator could rupture propelling pieces of the metal inflator under force sufficient to cause injury.

1. Install the new steering wheel airbag module (1). Refer to *Steering Wheel Airbag Replacement* in SI.
2. **DO NOT** deploy the removed steering wheel airbag module. The removed steering wheel airbag module is to be retained. Additional information will be communicated on the proper method of disposal for these steering wheel airbag modules at a later date.
