Safety Recall

Code: 28H1

Ignition Switch (WIN Module)

U.S.A. & CANADA: 2009-2010 MY Routan

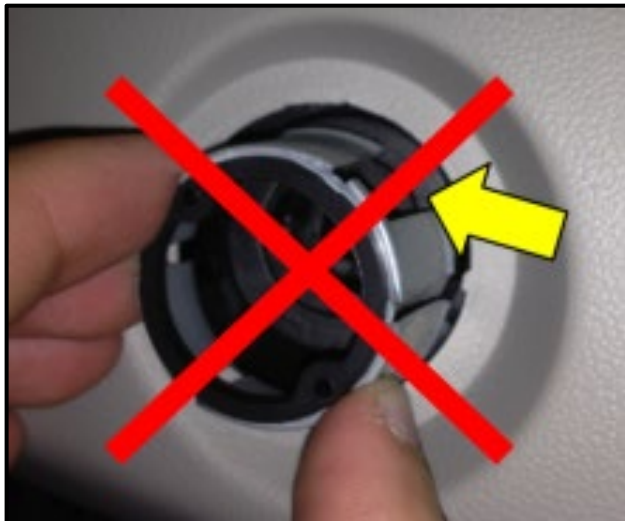
If the detent ring <arrow> was installed previously under the 28G1 action, it **MUST** be discarded during this step. **DO NOT** reinstall the detent ring.

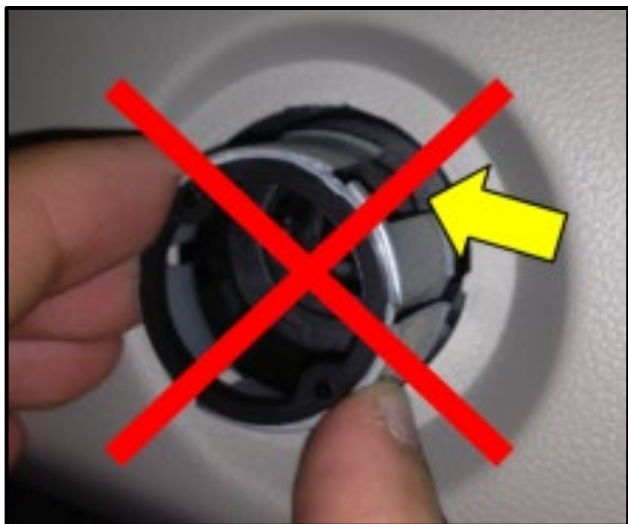
! NOTE
If the detent ring <arrow> was installed previously under the 28G1 action, it MUST be discarded. DO NOT reinstall the detent ring.
