Service Bulletin

SAFETY RECALL

2014-2015 CBR1000S (CBR1000RR SP) REAR SHOCK ABSORBER REPAIR

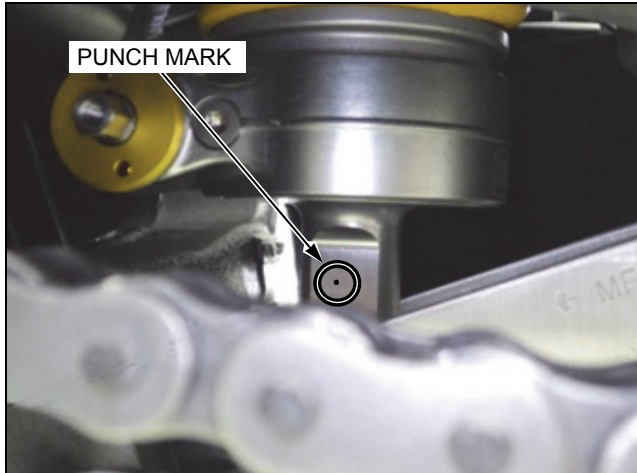
Check that the returned shock absorber has identifying punch mark from Öhlins.
