# ***SERVICE PROCEDURE***

15510

**SUBJECT:**    **SAFETY RECALL**  
**LINEAR POWER MODULE (LPM) on certain AE**  
**school bus models built 14 February 2013 thru 10**  
**March 2014.**

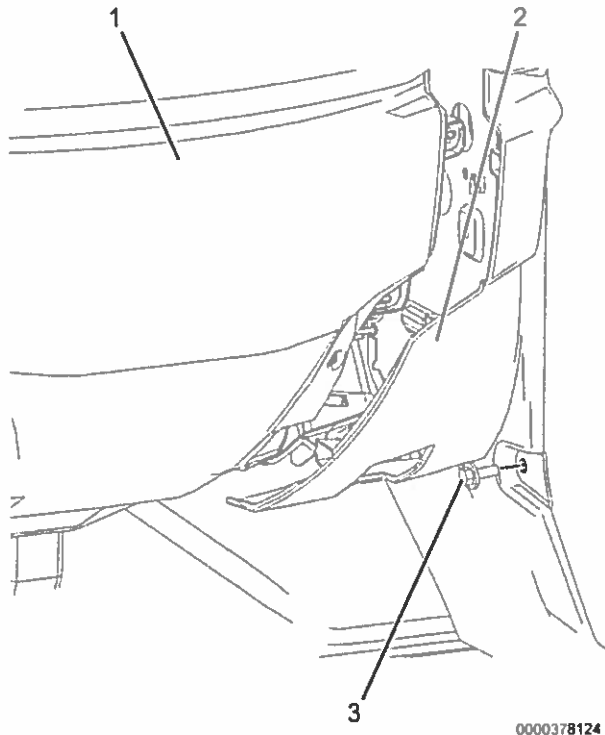
**Figure 1. Floor Duct Trim Panel.**

- 1. HVAC housing trim panel
- 2. Passenger floor duct trim panel
- 3. Bolt

- 6. Remove screw from passenger-side door interior trim sill plate.
- 7. Remove bolt (Figure 1, Item 3) from floor duct trim panel (Figure 1, Item 2).
- 8. Using fiber stick or equivalent, disengage locking clips securing passenger floor duct trim panel to HVAC housing trim panel (Figure 1, Item 1).
- 9. Carefully remove passenger floor duct trim panel.

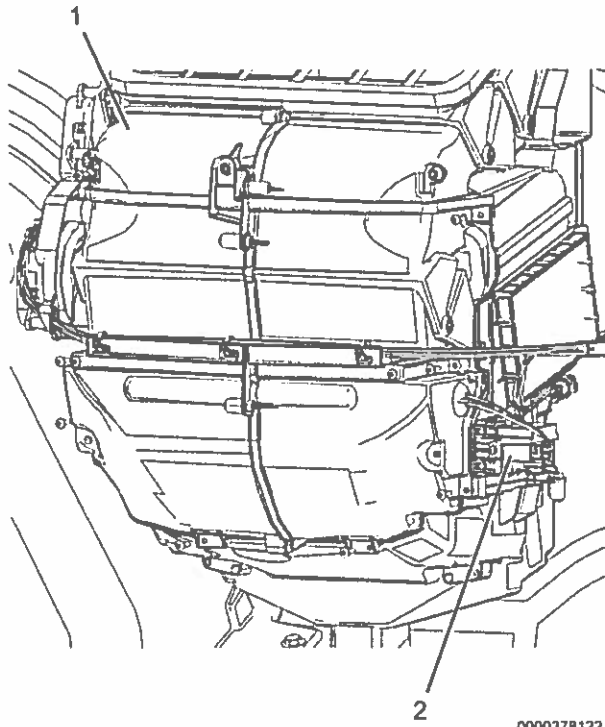
**Figure 2. Interior HVAC Module.**

- 1. Interior HVAC module
- 2. Linear Power Module (LPM)

10. Access interior HVAC module (Figure 2, Item 1) and locate LPM (Figure 2, Item 2).

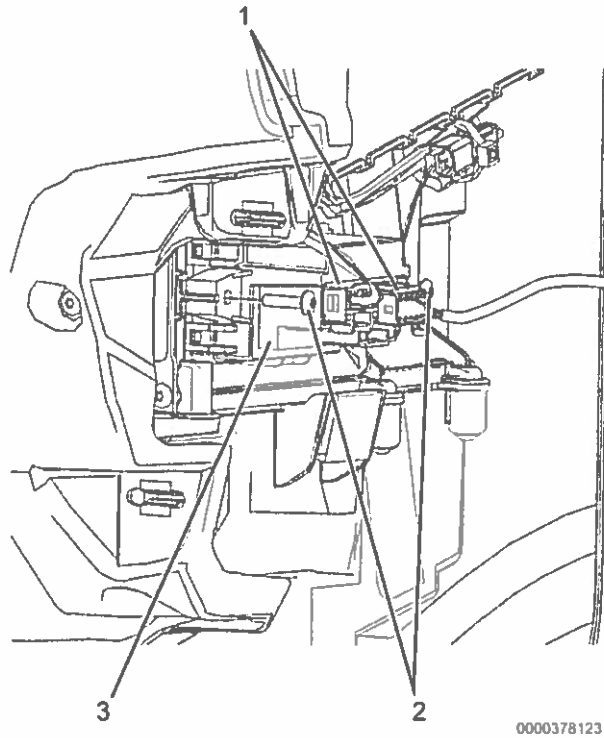
**Figure 3. Linear Power Module.**

- 1. LPM electrical connector (2)
- 2. Screw (2)
- 3. LPM

11. Disconnect two LPM electrical connectors (Figure 3, Item 1).

12. Remove two screws (Figure 3, Item 2) securing LPM (Figure 3, Item 3), and remove LPM.

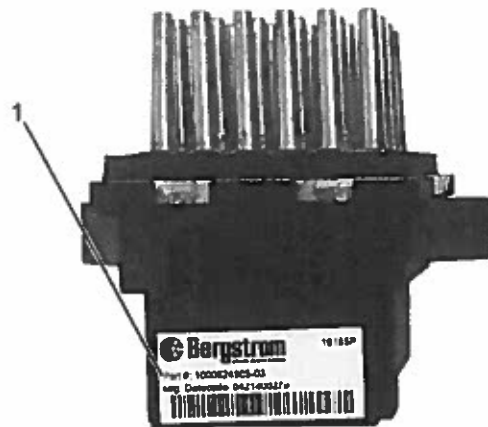
**Figure 4. Linear Power Module Part Number Label.**

1. Part number

13. Inspect the Bergstrom Part Number (Figure 4, Item 1) on the top of the LPM:

- a) If Bergstrom Part Number is 1000624505-XX, LPM does not require replacement. Reinstall LPM to interior HVAC module and secure with two screws. Using torque wrench, tighten screws to 20 lb-in (2.2 N·m). Proceed to Step 15.
- b) If Bergstrom Part Number is 1000326858-XX, LPM requires replacement. Proceed to Step 14.

14. If necessary, install new LPM to interior HVAC module and secure with two screws. Using torque wrench, tighten screws to 20 lb-in (2.2 N·m).
