# Recall Bulletin

**SUBJECT:** Safety Belt Lap Anchor Tensioner Cable

**MODELS:** 2011-2012 Chevrolet Malibu

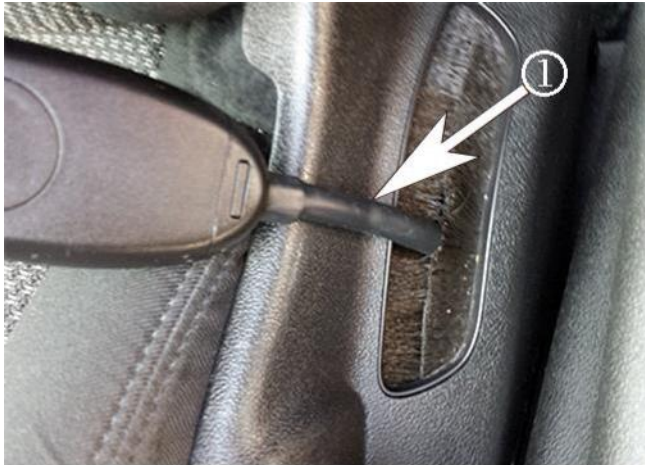
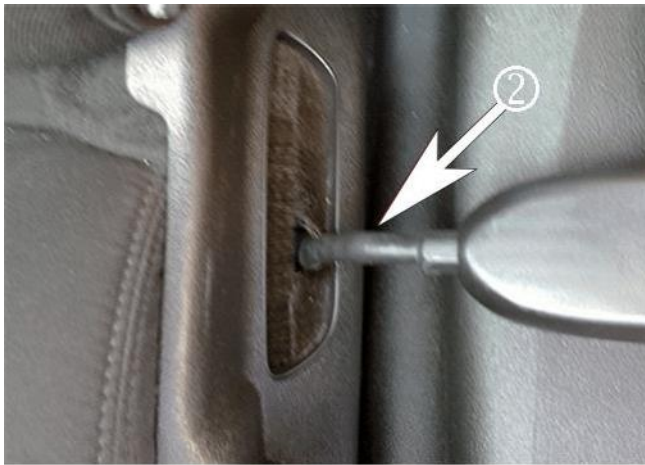
1. Move the front seats to the full rearward and full downward position.

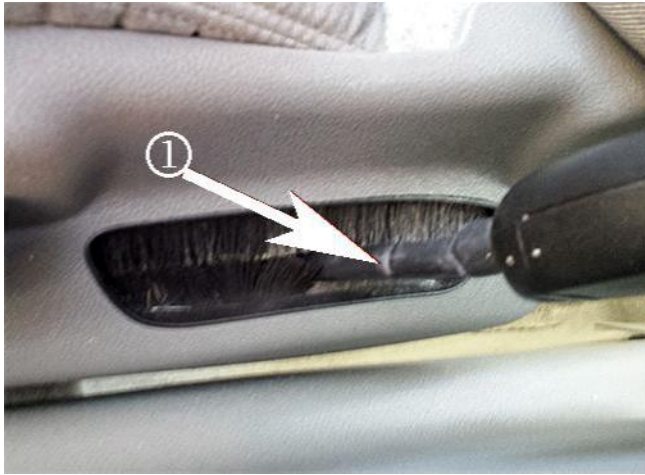
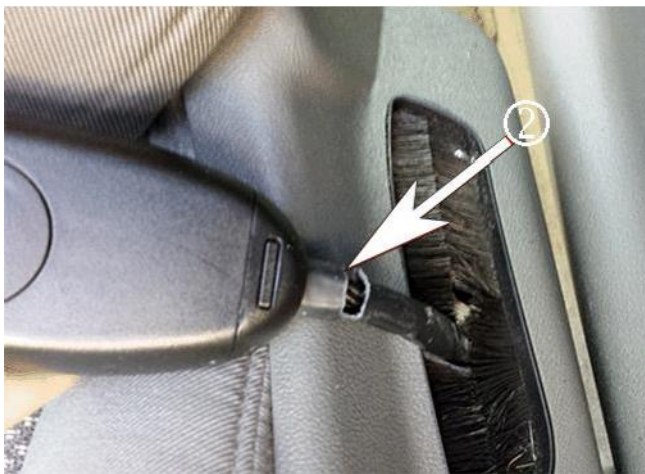
2. Inspect the safety belt shrink sleeve for any cuts or cracks. Bend the seat belt cable toward the inside (1) and outside (2) of the vehicle and carefully inspect for any cuts or cracks in the shrink sleeve.

3. If a sleeve is cut or cracked on the cable (1) or where the cable meets the buckle (2), replace the front seat belt anchor plate tensioner in step #10.
4. Remove the front seat belt anchor plate tensioner. Refer to *Front Seat Belt Anchor Plate Tensioner Replacement* in SI. If the shrink sleeve does not show any damage, it is not necessary to disconnect the anchor plate from the belt.

10. Reinstall the seat belt anchor plate tensioner. If the shrink sleeve was found to be damaged in step #2 above, replace the affected front seat belt anchor plate tensioner. Refer to *Front Seat Belt Anchor Plate Tensioner Replacement* in SI.
