Recall Bulletin

PRODUCT SAFETY RECALL

SUBJECT: Safety Belt Lap Anchor Tensioner Cable

MODELS: 2011-2012 Chevrolet Malibu

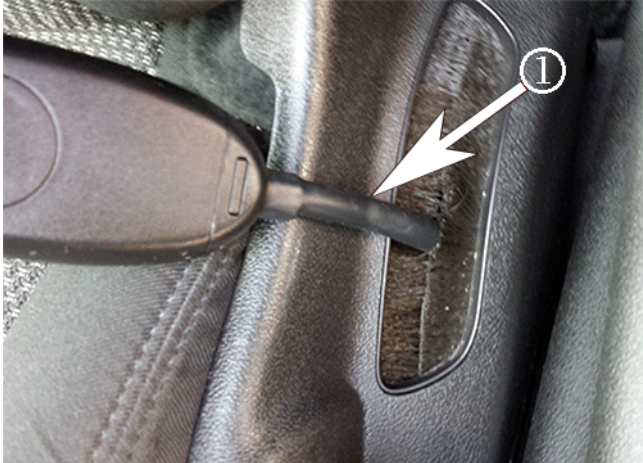
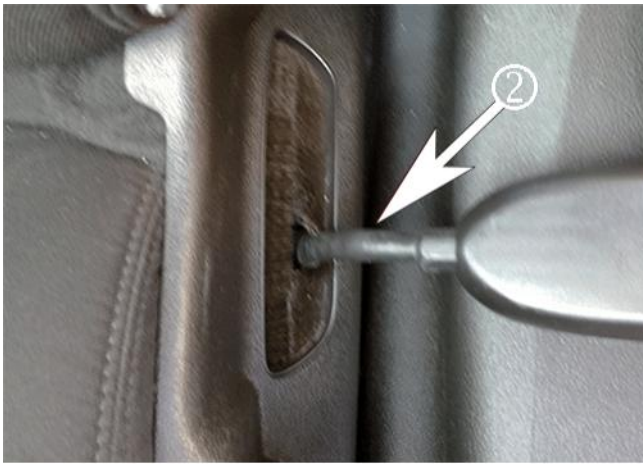
1. Move the front seats to the full rearward and full downward position.

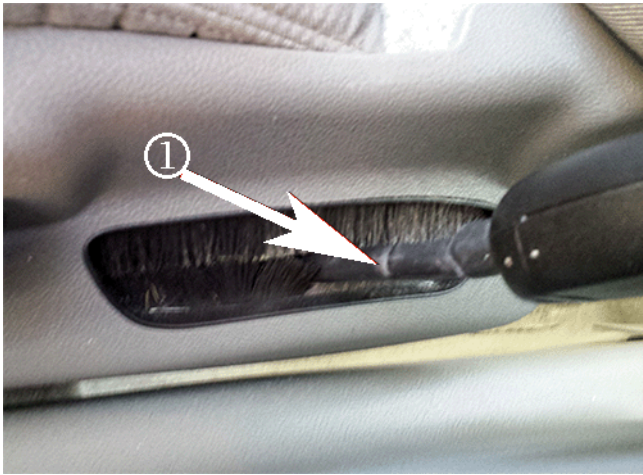
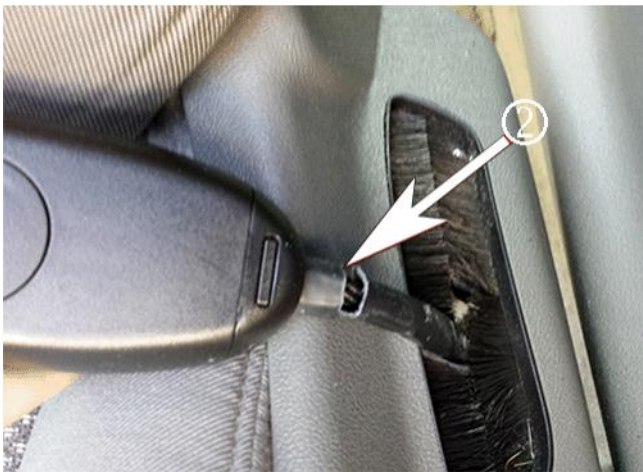
2. Inspect the safety belt shrink sleeve for any cuts or cracks. Bend the seat belt cable toward the inside (1) and outside (2) of the vehicle and carefully inspect for any cuts or cracks in the shrink sleeve.

3. If a sleeve is cut or cracked on the cable (1) or where the cable meets the buckle (2), replace the front seat belt anchor plate tensioner in step #10.
4. Remove the front seat belt anchor plate tensioner. Refer to *Front Seat Belt Anchor Plate Tensioner Replacement* in SI. If the shrink sleeve does not show any damage, it is not necessary to disconnect the anchor plate from the belt.
