# Recall Bulletin

## PRODUCT SAFETY RECALL

**SUBJECT:** Front Passenger Air Bag Inflator Module

**MODELS:** 2004-2007 Pontiac Vibe  
Currently Registered or Previously Registered in Alabama, Florida, Georgia, Hawaii, Louisiana, Mississippi, South Carolina, Texas, Guam, Puerto Rico, Saipan, U.S. Samoa or U.S. Virgin Islands

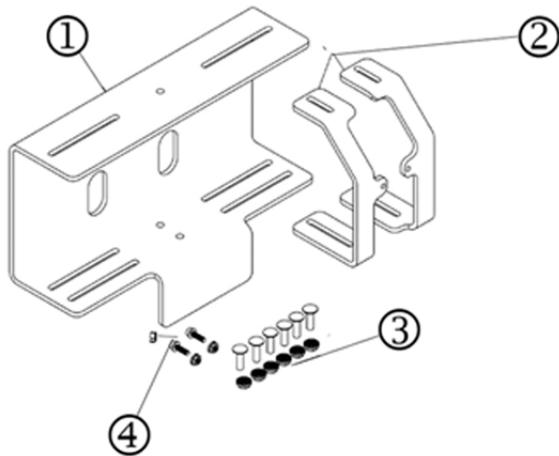
4006668

(1) Mounting Bracket (2) Support Bars (3) Support Bar Hardware (4) Air bag Mounting Hardware.

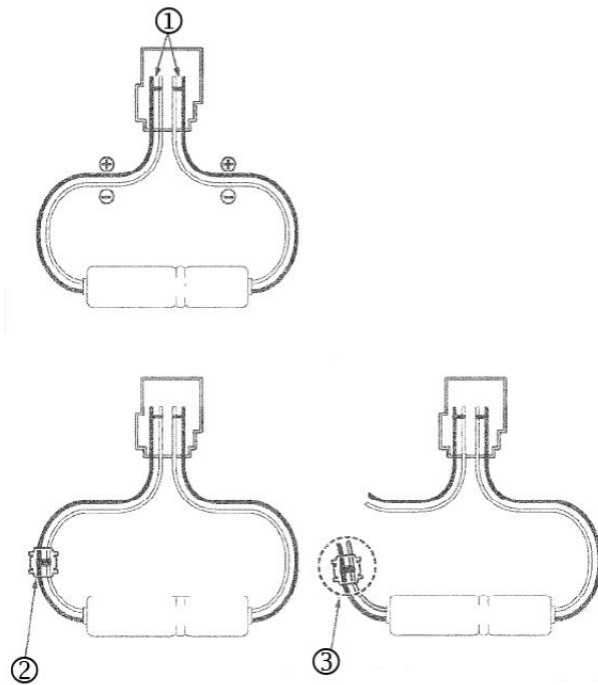
3470510

**Note:** The connector of an air bag inflator has a short-circuiting mechanism that eliminates voltage difference when disconnected (1). To allow for the replacement of the inflator module, a new short circuit using an electro tap (2) **MUST** be created **BEFORE** cutting the wires (3) and removing the inflator.

7. Create a short circuit before disconnecting the inflator wire harness.

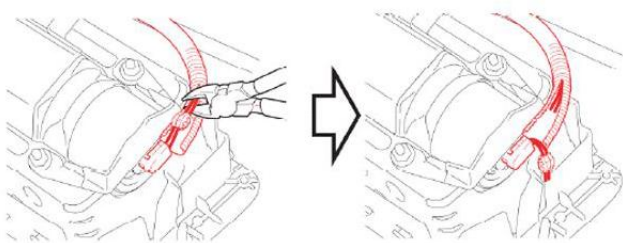
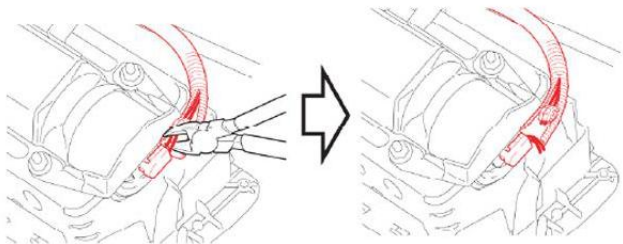
3470348

OK: Cut wires at opposite side to inflator. NG: Do NOT cut at inflator side.

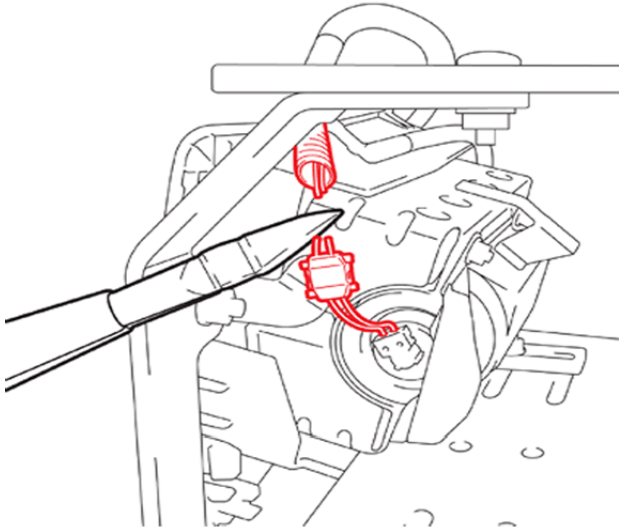
3607837

**Caution:** Ensure to cut the two wires at the correct location. Refer to the illustration.

8. Cut the two wires at the side of the electro tap opposite to the inflator (the side of the electro tap that is farthest away from the inflator).

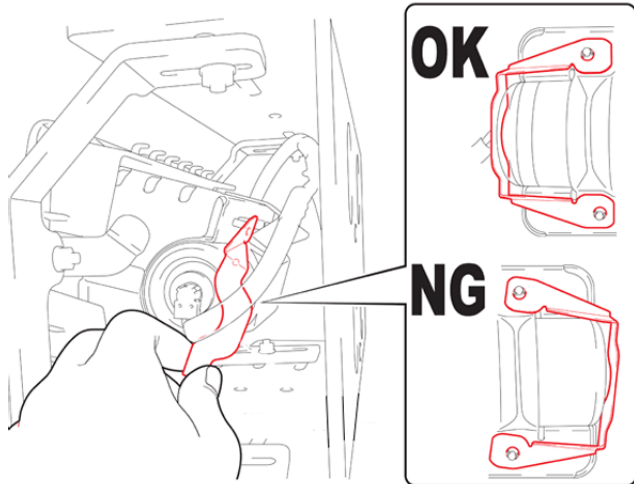
3607886

14. Confirm the identification of the stopper and the position determining plate. **THEY ARE DIFFERENT.** Refer to the illustration: (1) Stopper Plate (2) Position Determining Plate.

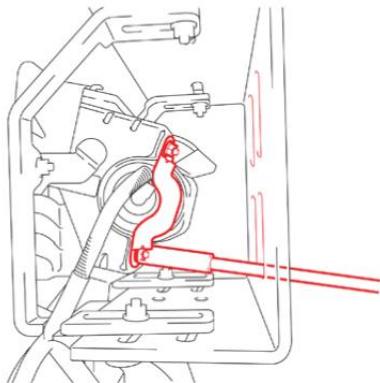
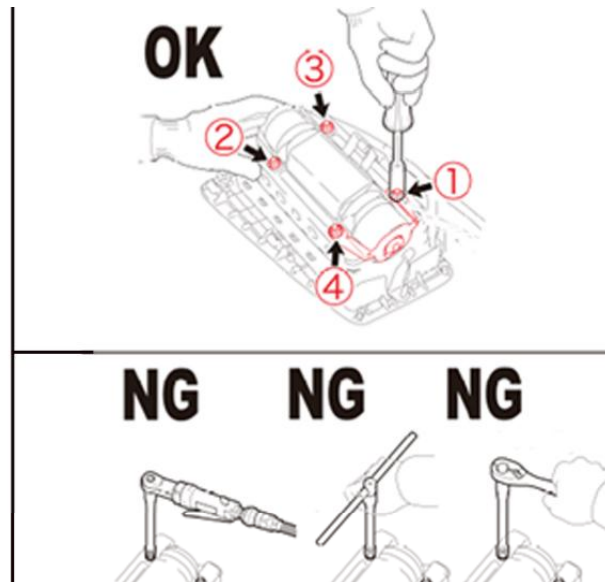
3610416

**Caution:** There will be some resistance when tightening the nuts because they are self-locking. Confirm the nuts are tightened correctly. **DO NOT** use a power tool, T-handle, or ratchet when tightening the nuts to avoid over-torqueing.

18. Tighten four (4) **NEW** plate nuts evenly in several increments in the order shown in the illustration using a 10 mm socket driver while pushing the inflator. (You will encounter some resistance during tightening because these nuts are self-locking nuts.)

**Torque Specification: 3.9 Nm (35 in-lb)**

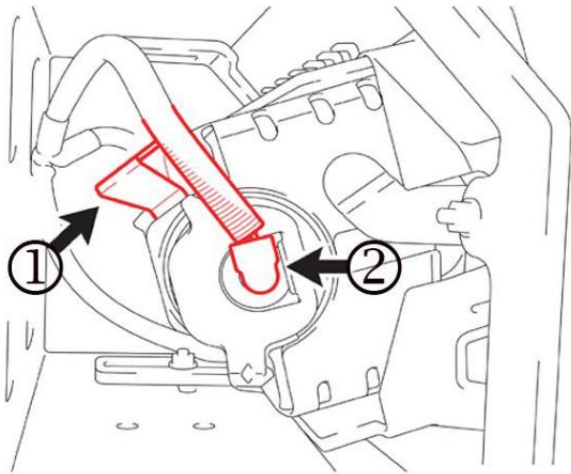
3610412

**Warning:** The connector should be connected *IMMEDIATELY* after removing the seal. Once the connector is installed it *CANNOT* be removed. If the connector is installed in the incorrect orientation the terminals may be bent or the connector may not fully engage.

19. Connect the inflator connector (2).

19.1 Remove the connector seal from the inflator.

19.2 Confirm the alignment of the harness connector as shown in the illustration, and then connect the harness. The connector wires should lead toward the center mounting bracket (1) on the air bag assembly.
