Recall Bulletin

PRODUCT SAFETY RECALL

SUBJECT: Front Passenger Air Bag Inflator Module

MODELS: 2003-2005 Pontiac Vibe
Currently Registered or Previously Registered in Alabama, Florida,
Georgia, Hawaii, Louisiana, Mississippi, Texas, Guam, Puerto Rico,
Saipan, U.S. Samoa or U.S. Virgin Islands

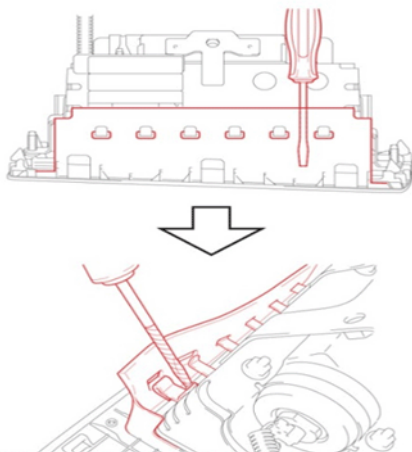
4486638

3. Remove the cover.

- 3.1. Gently insert the screwdriver between the air bag door and module and disengage the claws holding the door to the module.
- 3.2. After all the claws have been disengaged, separate the module from the door.
- 3.3. Mark the old module so it is not reused.
- 3.4. Inspect the door for damage to the mounting slots.
