SERVICE BULLETIN

Number: 15-001

GM 6.6L Cable Connection Mandatory Product Improvement

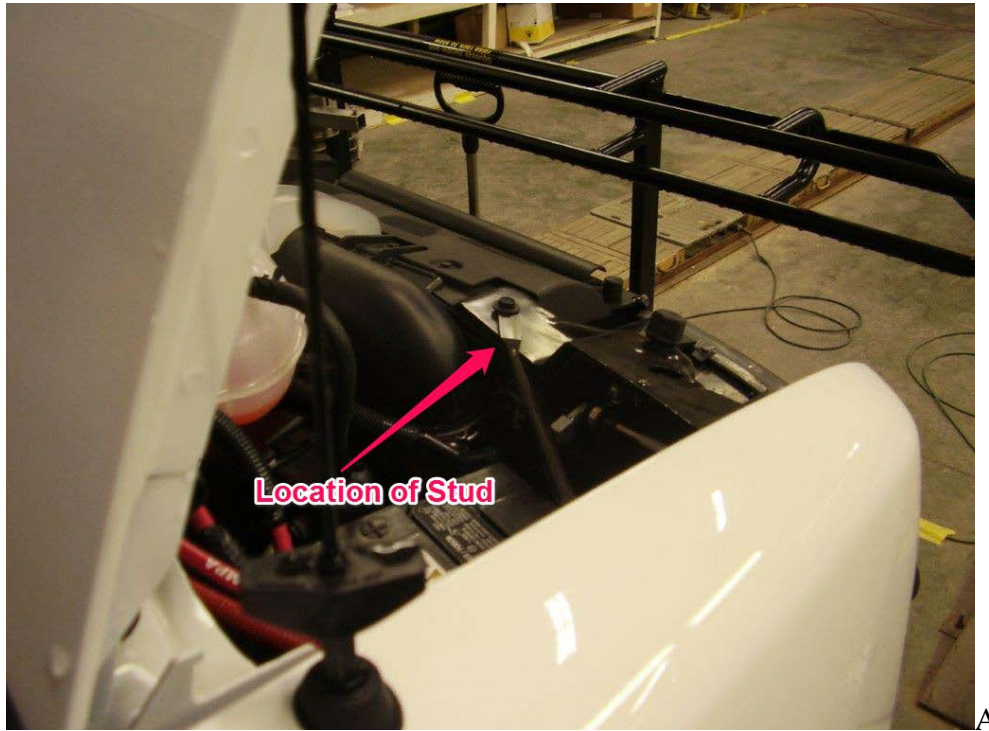
Fig 1

1. Open hood.
2. Locate the terminal strip (three studs) See Fig. 1 & Fig 2
3. Verify that the cable (blue) on the stud nearest the driver's side is secured correctly. See Fig. 3 & Fig 4

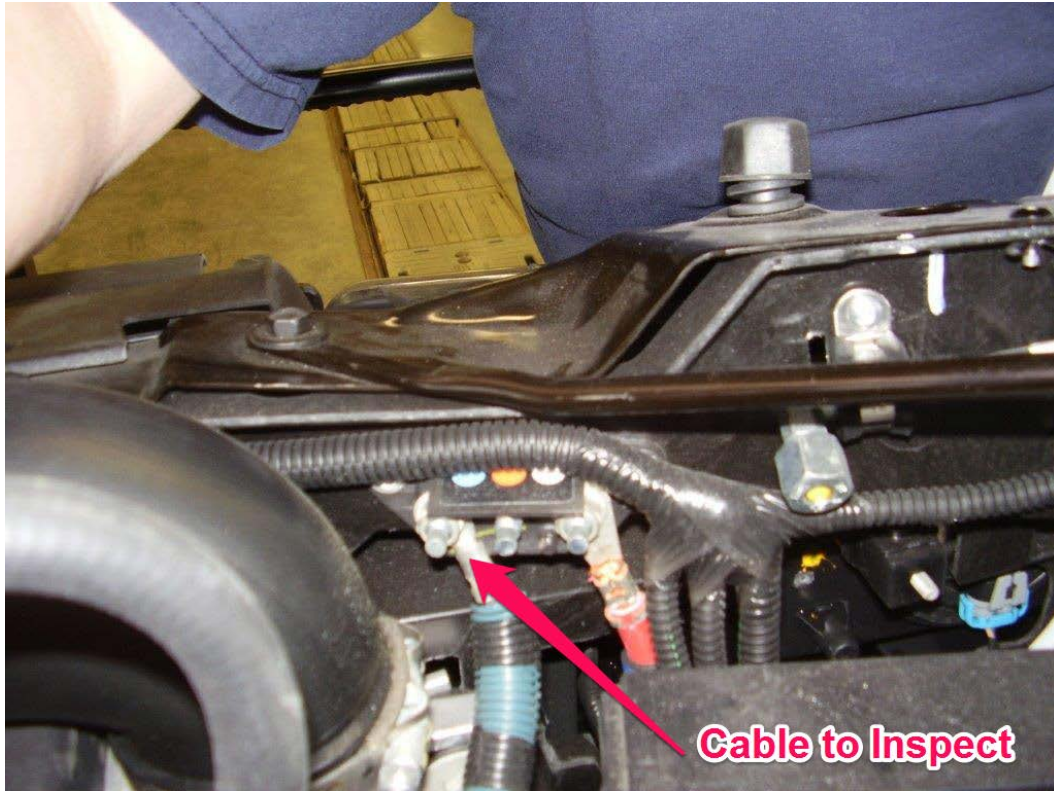
Fig 3

Trans/Air has become aware of isolated instances where, the cable routed across the top of the fan shroud is not properly positioned on the terminal strip, located at the front of the engine compartment. This could cause a poor connection, or a loose connection, causing heat or arcing, and leading to a possible ignition source.

Inspect cable-to-stud connection. If the cable is angled (off vertical) over the edge of the terminal strip, loosen the self-locking nut and slightly rotate the cable to its proper vertical position, and tighten the nut securely.
