Revision (2) November 2022

Dealer Service Instructions for:

Safety Recall R25 / NHTSA 15V-313

Driver Airbag Inflator

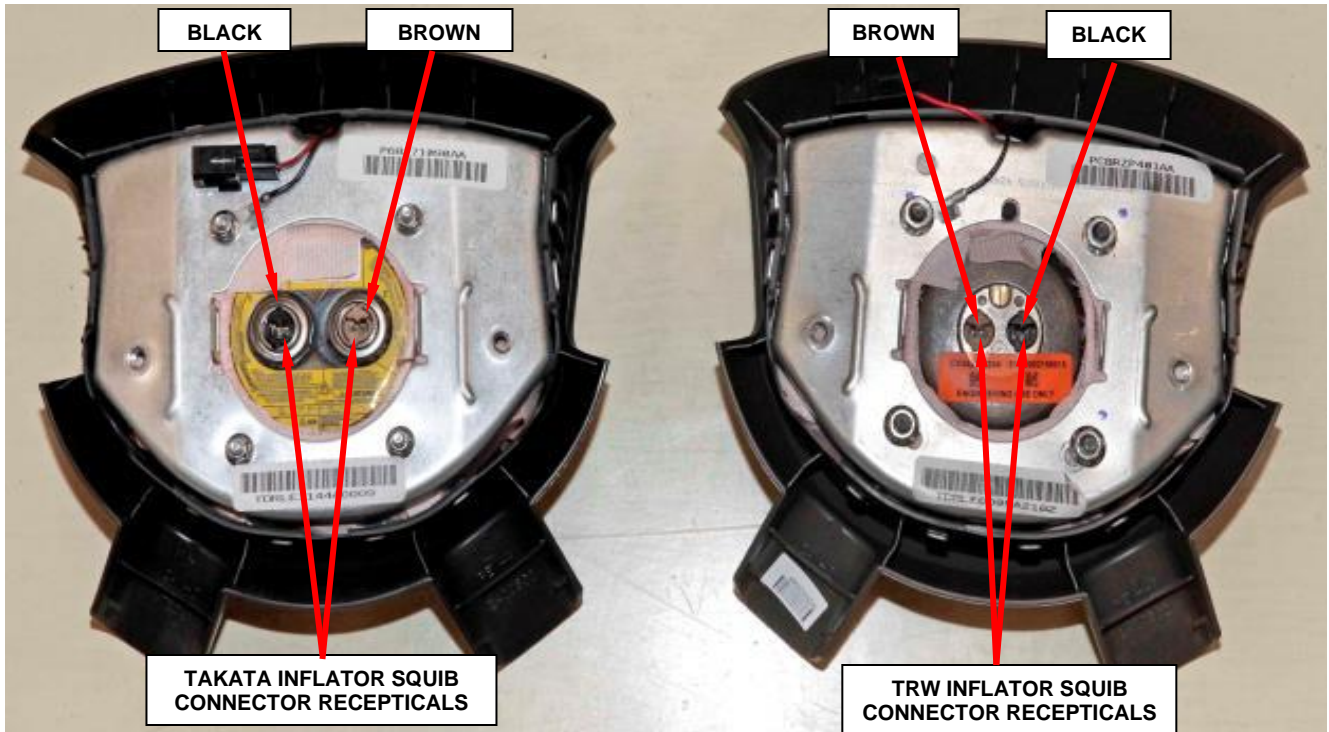
Figure 14 – Squib Connector Receptacles

NOTE: The squib connector receptacle locations on the driver airbag inflators are switched between the original Takata inflator and the TRW replacement inflator kits. Squib connectors are keyed and color coded for error proofing (Figure 14).

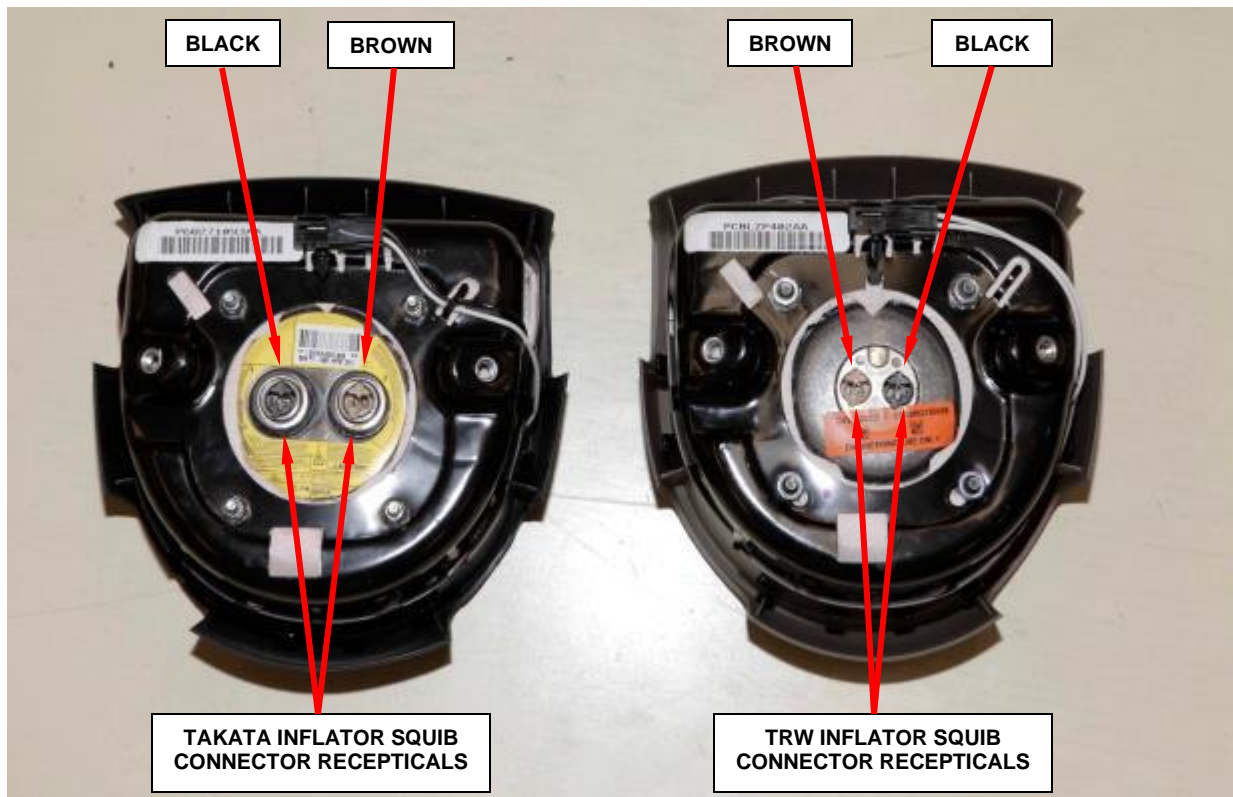
Figure 24 - Squib Connector Receptacles

NOTE: The squib connector receptacle locations on the driver airbag inflators are switched between the original Takata inflator and the TRW replacement inflator kits. Squib connectors are keyed and color coded for error proofing (Figure 24).
