**AF05 - Checking and Reworking Wire Harness for Left Rear Radiator Fan (Stop Sale Campaign/Recall Campaign)**

Vehicle Type: **918 Spyder**

Model Year: **2015**

Concerns: **Wire harness for rear left radiator fan**

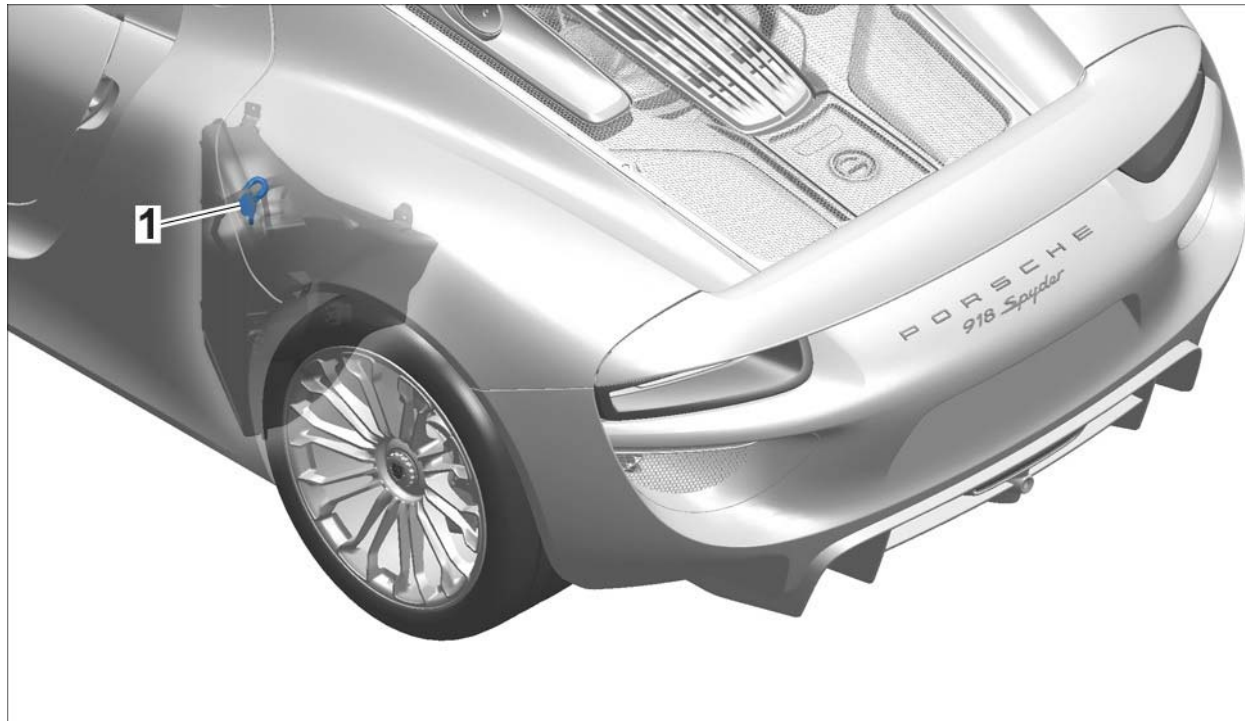
*Installation position of wire harness for rear left radiator fan*

- 1 – Connector for wire harness for rear left radiator fan

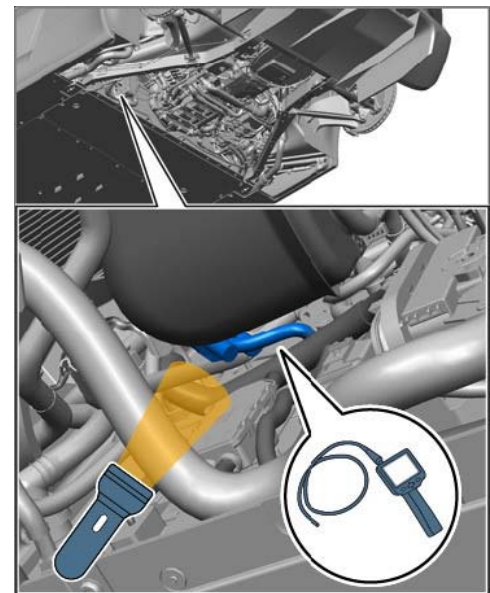
- 1 Visually inspect the wire harness using the endoscope or using a suitable inspection mirror and check for visible chafing marks on the wire harness for the radiator fan.
  - If there are no chafing marks visible on the wire harness, fit the tie-wrap clip and reassemble the vehicle. To do this, **continue with Step 2**.
  - If there are visible chafing marks on the wire harness, take photos of these using the endoscope or a digital camera and attach the photos to the PQIS job and submit a PTEC-TLAR to PCNA for further instructions.

*Checking wire harness for radiator fan*

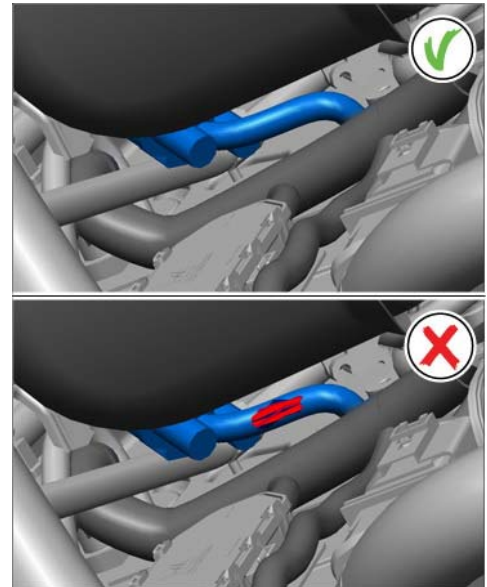
*Assessment of wire harness  
for radiator fan*

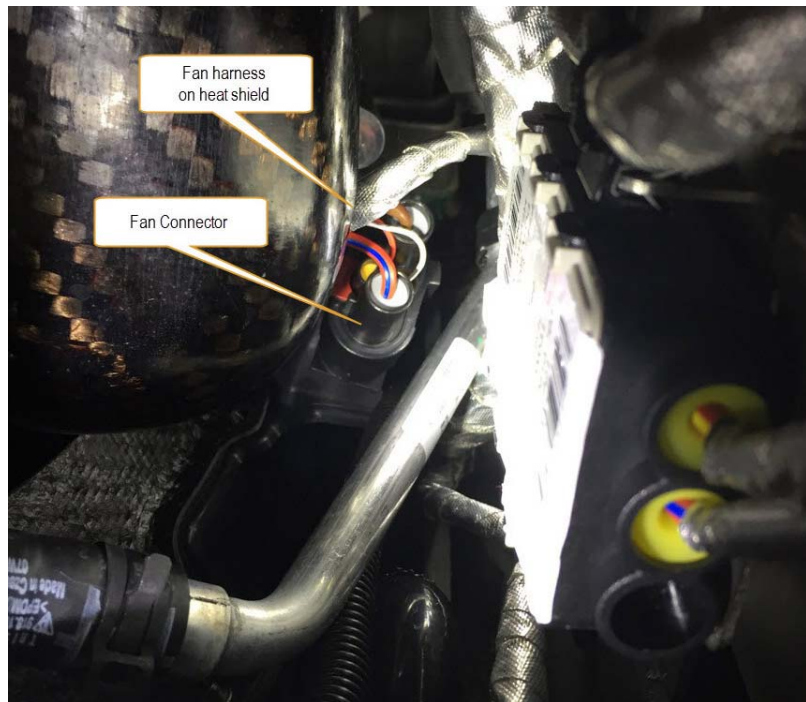
*Before*

1.1 Before and after pictures to use as a reference.

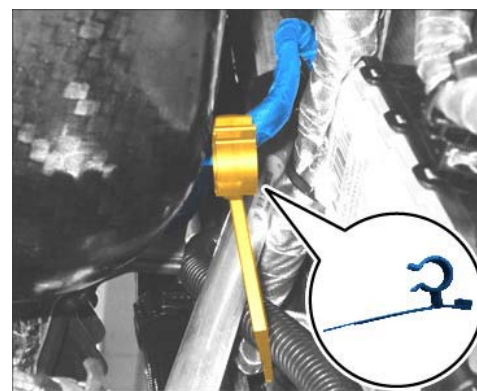
*Fitting tie-wrap clip*

- 2 Fit tie-wrap clip on wire harness for radiator fan.
  - 2.1 Fit tie-wrap clip around the wire harness as shown ⇒ *Fitting tie-wrap clip* and close it, but do not tighten it yet.

Depending on how the harness is routed, it may be difficult to reroute to the desired position as shown in the diagram. In this case, it is important to assure that the harness is sufficiently pulled away from the heat shield to avoid any potential contact.

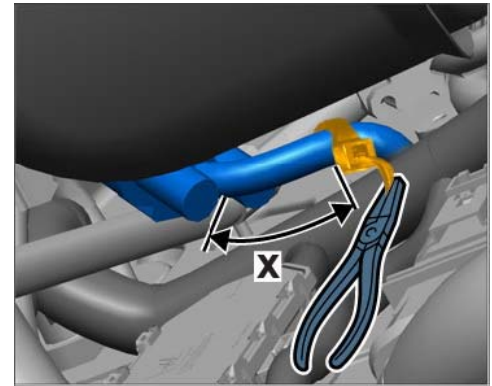
*Securing tie-wrap*

- 2.2 The tie-wrap clip should be secured at a defined distance from the connector on the wire harness.  
To do this, measure a distance of  $\Rightarrow$  *Securing tie-wrap - X = 70 mm*- from the lower edge of the connector using a ruler and mark this position on the wire harness.
- 2.3 Position tie-wrap clip at the marking and tighten it using needle-nose pliers.

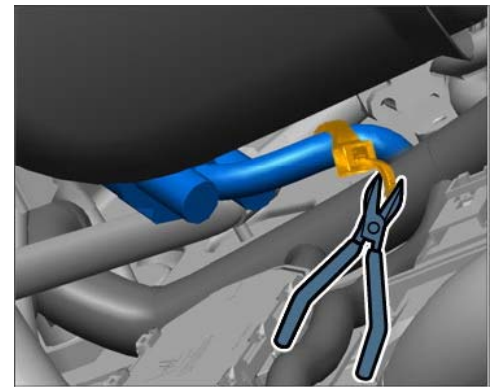
*Fitting tie-wrap*

- 2.4 Cut off the extra length at the end of the tie-wrap using side cutters.

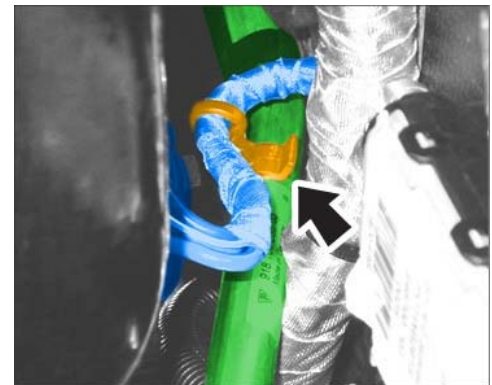
*Securing wire harness*

- 2.5 Clip in tie-wrap clip on the coolant pipe above the main wire harness.
- 2.6 Check that the wire harness is routed correctly and has sufficient clearance from the heat guide plate.
