Bulletin No.: 15352

## PRODUCT SAFETY RECALL

SUBJECT: **Brake Pedal Push Rod Retention Failure**

MODELS: 2015 Cadillac ATS, CTS

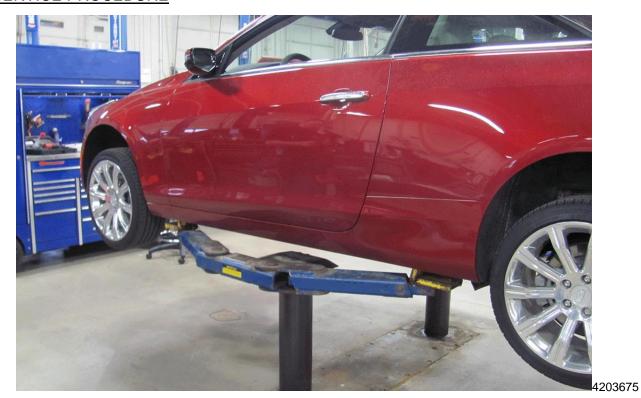
- 1. Partially raise and support the vehicle. Refer to Lifting and Jacking the Vehicle in SI.
- 2. Locate the brake pedal assembly.

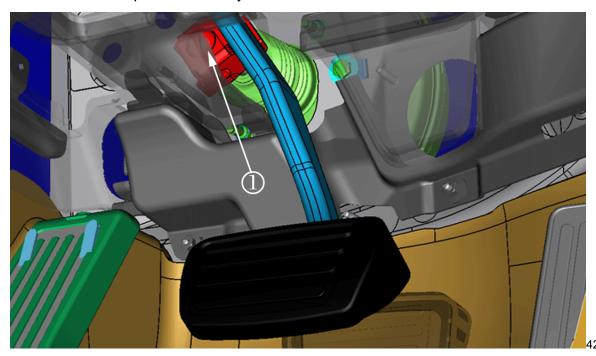
3. Using a borescope, locate the booster dome (1). Insert the borescope camera with lights turned on between the instrument panel knee bolster and brake pedal arm. Route the borescope along the left side of the brake pedal assembly. The booster dome is located just above the bottom edge of the instrument panel knee bolster. Tilt the borescope on a 45 degree angle and to the left to view the booster dome.

4. The booster dome will have a single or double dome shape. Determine the shape of the booster dome.
