## Subject: Takata Driver Side Airbags

**Models Affected:** Specific model year 2008-2009 Sterling Bullet vehicles manufactured October 15, 2007, through November 10, 2008, with Takata Corporation driver side air bags.

# Recall Campaign

June 2017  
FL684A-D  
NHTSA #15V-361  
Transport Canada #15-257  
THIRD REVISED NOTICE

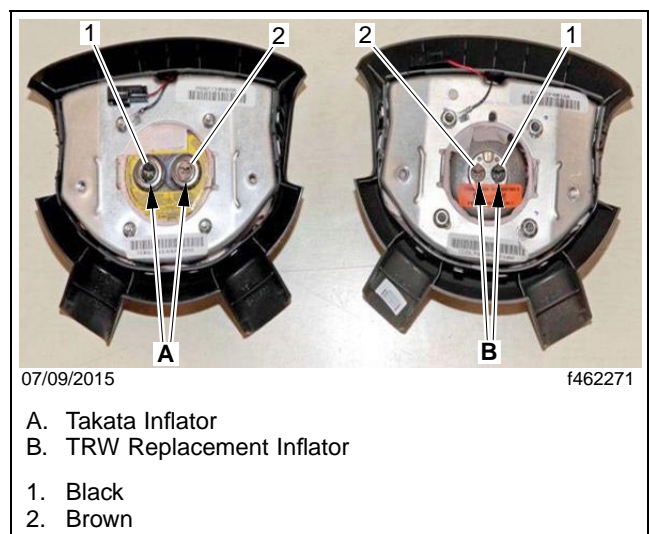
**Fig. 8, Squib Connector Receptacles**

- NOTE: The squib connector receptacle locations on the driver air bag inflators are switched between the original Takata inflator and the TRW replacement inflator kits. Squib connectors are keyed and color coded for error proofing. See **Fig. 8**.

18. Connect the two driver air bag squib connectors to the driver air bag inflator assembly connector receptacles by pressing straight in on the connector. Make sure to engage each keyed and color-coded connector to the matching connector receptacle. Make sure that each connector is fully engaged in its receptacle by listening carefully for a distinct, audible click as the connector latches snap into place.
