Industrial Axle Company, LLC

NOTICE OF PRODUCT SAFETY RECALL

SAFETY RECALL NOTICE

Manufacturer recall of 6 bolt hub/drum using ½-20 zinc coated wheel studs

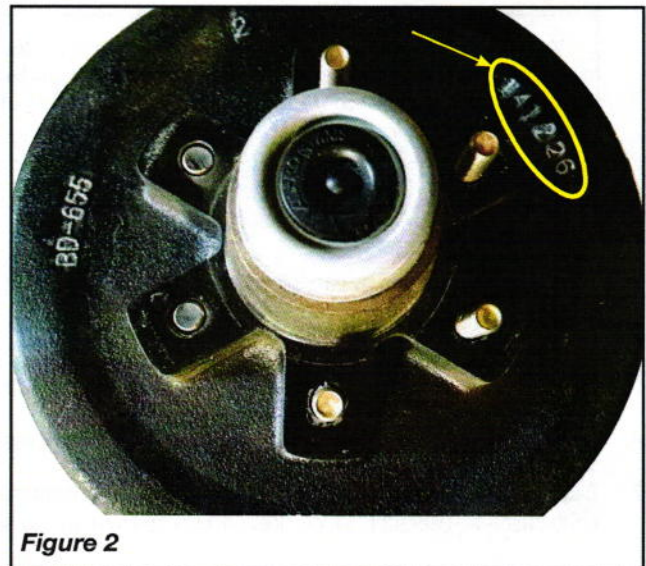
Figure 2

- Affected hub/drum part number is 363239.9.
- Suspect hub/drums have the date code of 141224, 141225, 141226, and 141227. Axles with date codes on the hub/drums outside these dates are OK to use. (See figure 2 on where to find the date code.)

- An example of where to find the the date code is shown in figure 2:

141226
year month day

- If you find any axles with a date on the hub/drum that matches the designated date range, please contact IAC at 1-800-400-2164 or via email (IACwarranty@industrialaxles.com) for a replacement(s) and to return suspect hub/drums. Please have the axle serial number when contacting us.

- In the event a suspect hub/drums is identified, please contact IAC for a replacement hub/drums kit (kit number 1684787).
- Labor allowance is 0.5 hour to jack the trailer up, remove the wheels, and check hub/drums date. Prior to removal of the wheels, check the axle tag to determine if the axle falls in the suspect purchase order group. If replacement is needed, 1.0 hour per axle will be allowed. Labor will be allowed at your posted hourly rate.

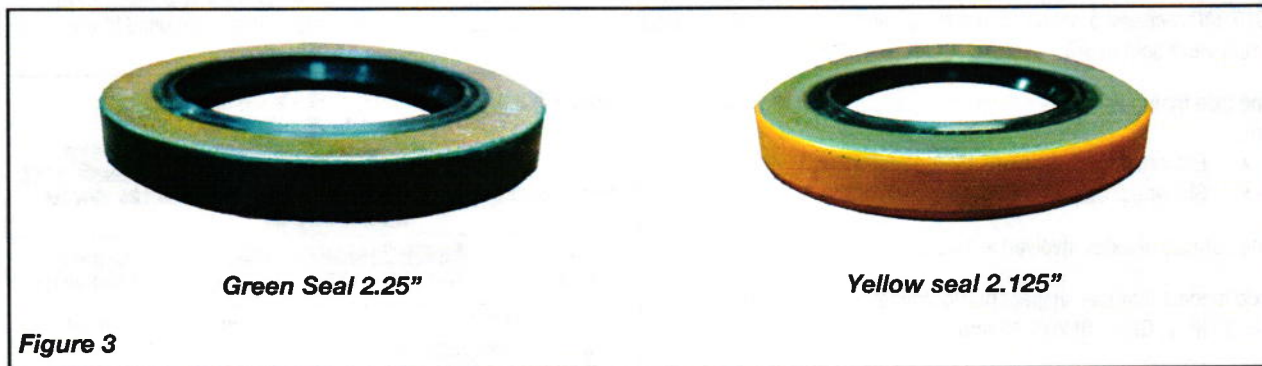
Replacement hub/drums will be shipped as part of a kit that includes a 2.25" green grease seal and a 2.125" yellow grease seal. See figure 3 of how to determine the correct seal needed for your hub/drums. The kit will also include a cotter pin, an Ultrulube® tang washer plus a new grease cap (one for standard grease and one for the Ultrulube® style).
