# Recall Bulletin

## PRODUCT SAFETY RECALL

**SUBJECT:** Power Lift Gate Prop Rod Recovery

**MODELS:** 2008-2012 Buick Enclave  
2009-2012 Chevrolet Traverse  
2007-2012 GMC Acadia  
2007-2010 Saturn Outlook  
Built Prior to March 1, 2012 and Equipped with Power Lift Gate (TB5 or E61)

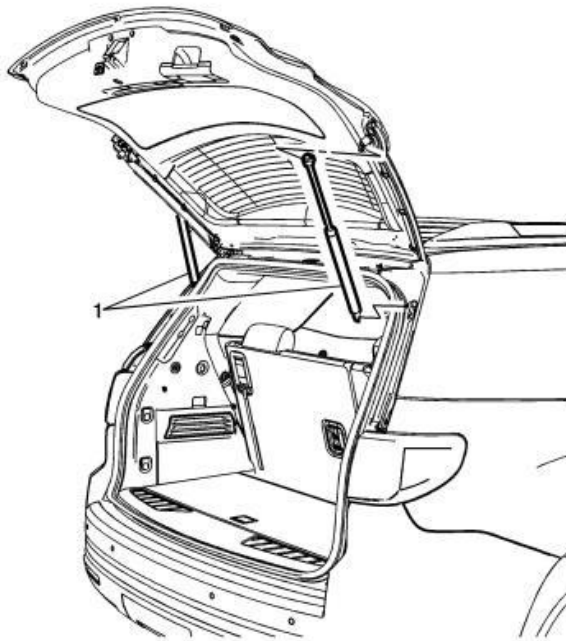
2878222

**Note:** GM engineering has determined that improved durability of the lift gate strut can be realized by installing the strut assembly with the rod end facing downward (attached to the lift gate) when the lift gate is in the closed position. In this orientation, dust and dirt does not collect on the strut housing to rod seal, which can cause wear on the seal.

**Note:** When replacing or repositioning the lift gate struts, install the strut assembly with the strut body end attached to the vehicle body and the rod side attached to the lift gate (1).
