**PRODUCT CAMPAIGN BULLETIN**

**APPLICABILITY:** 2012 MY Impreza (except WRX/STI)

**NUMBER:** WQT-55

**SUBJECT:** Occupant Detection System (ODS)  
 Occupant Control Unit (OCU)

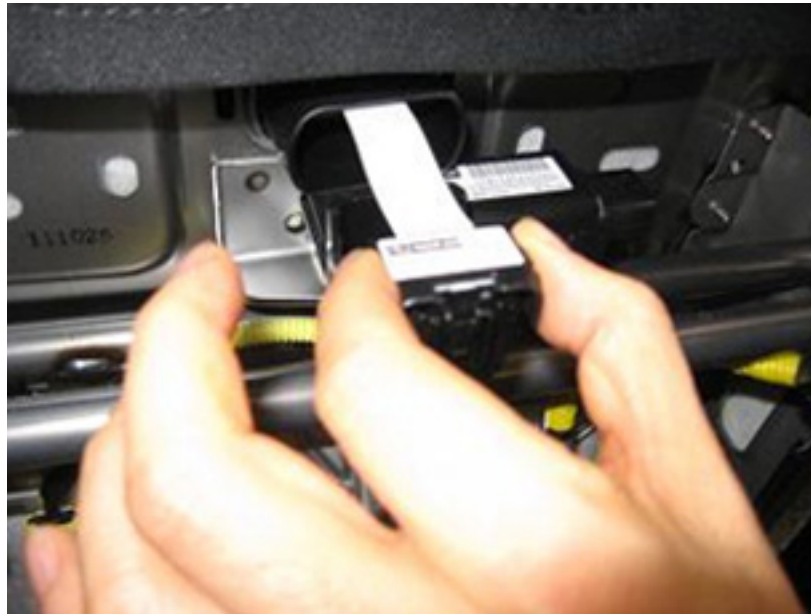
**NOTE:** The Mat Sensor wiring harness is a ribbon type and can be damaged easily if mishandled.
