Dealer Service Instructions for:

Safety Recall R37 / NHTSA 15V-444 Driver Airbag Inflator

2008-2010 (LC) Dodge Challenger

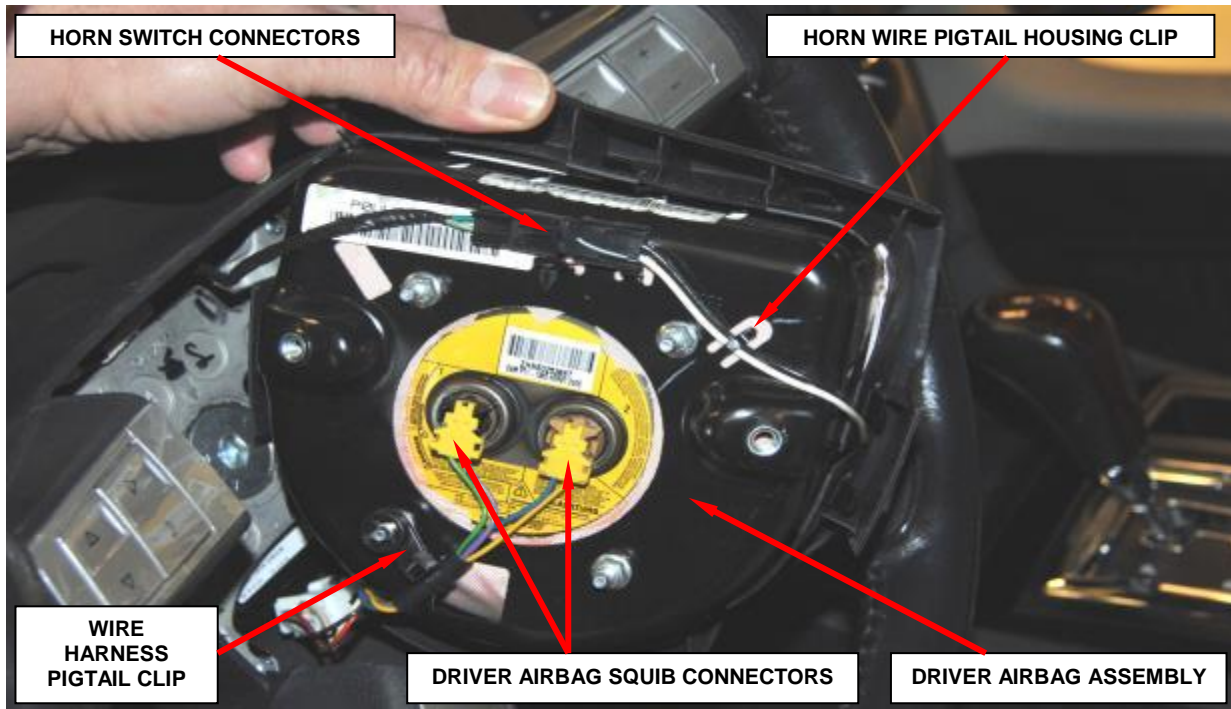
**Figure 2 – Electrical Connectors**

NOTE: The squib connector receptacle locations on the driver airbag inflators are switched between the original Takata inflator and the TRW replacement inflator kits. Squib connectors are keyed and color coded for error proofing (Figure 2).

4. Pull the driver airbag assembly away from the steering wheel far enough to access the three electrical connections on the back of the airbag housing (Figure 2).
5. Disconnect the steering wheel wire harness connector for the horn switch from the horn switch feed pigtail wire connector, which is located on the back of the driver airbag housing (Figure 2).
