Revision (1) November 2022

Dealer Service Instructions for:

Safety Recall R37 / NHTSA 15V-444

Driver Airbag Inflator

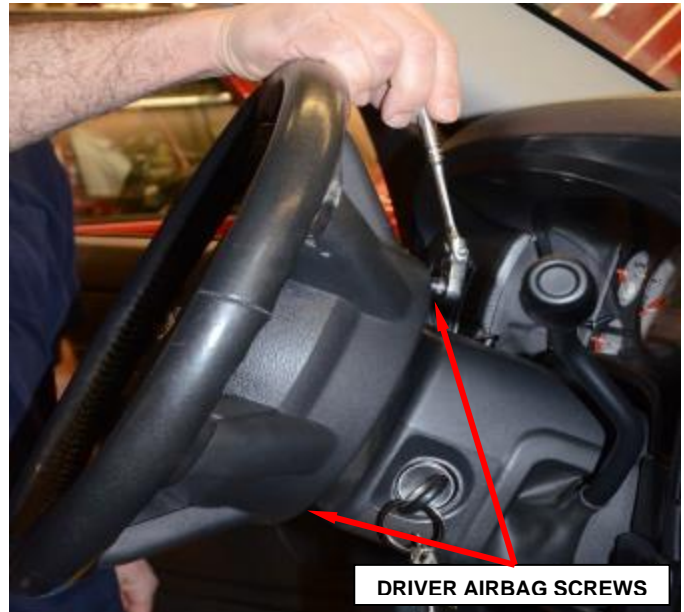
Figure 1 - Driver Airbag Screw Location

1. Use this procedure to replace the driver airbag inflator.
2. Disconnect and isolate the negative battery cable. Wait two minutes for the system capacitor to discharge before further service.
3. Remove and save the two screws that secure the driver airbag assembly to the steering wheel armature from the underside of the steering wheel (Figure 1).

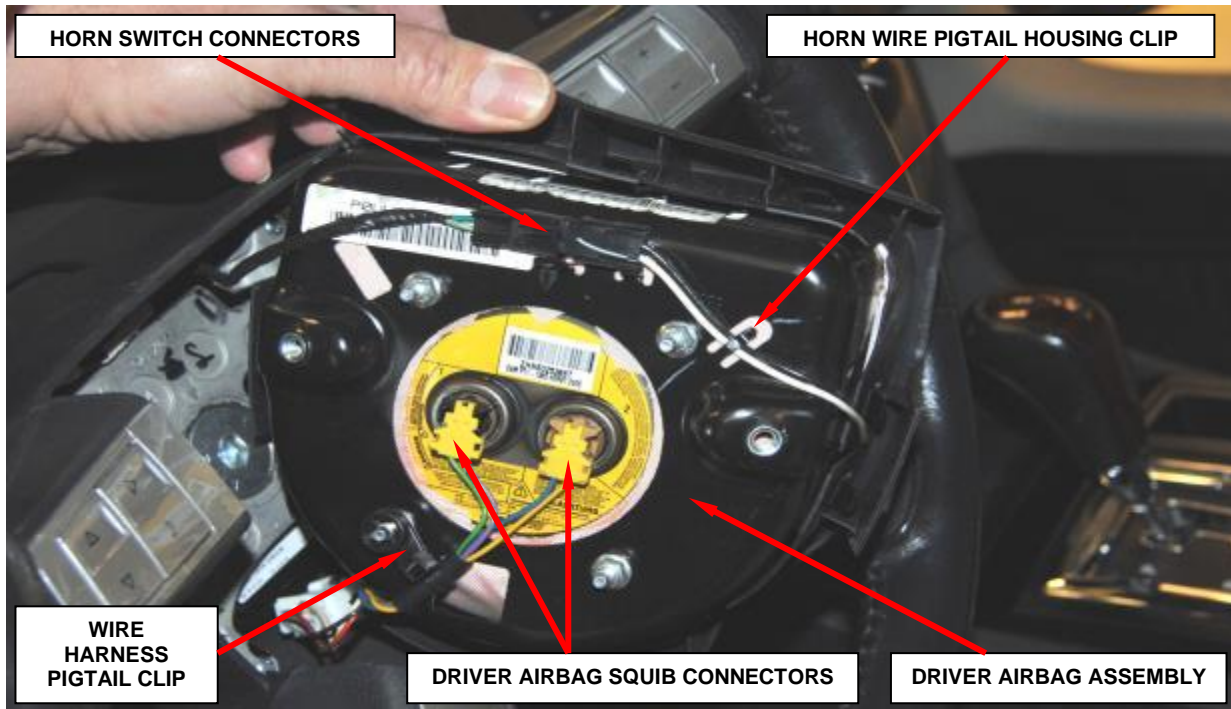
**Figure 2 – Electrical Connectors**

4. Pull the driver airbag assembly away from the steering wheel far enough to access the three electrical connections on the back of the airbag housing (Figure 2).
5. Disconnect the steering wheel wire harness connector for the horn switch from the horn switch feed pigtail wire connector, which is located on the back of the driver airbag housing (Figure 2).

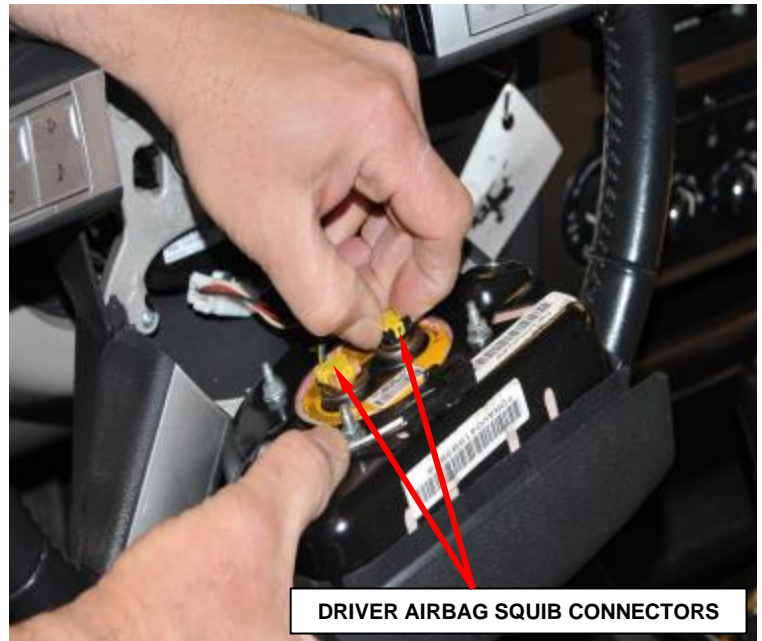
Figure 3 – Airbag Squib Connectors

6. Disconnect the driver airbag squib connectors. Depress the latches on each side of the connector insulator and pull the insulators straight out from the airbag inflator to disconnect them from the connector receptacles (Figure 3).
7. Disengage the wire harness pigtail clip from the housing (Figure 4).
8. Remove the driver airbag assembly from the steering wheel.

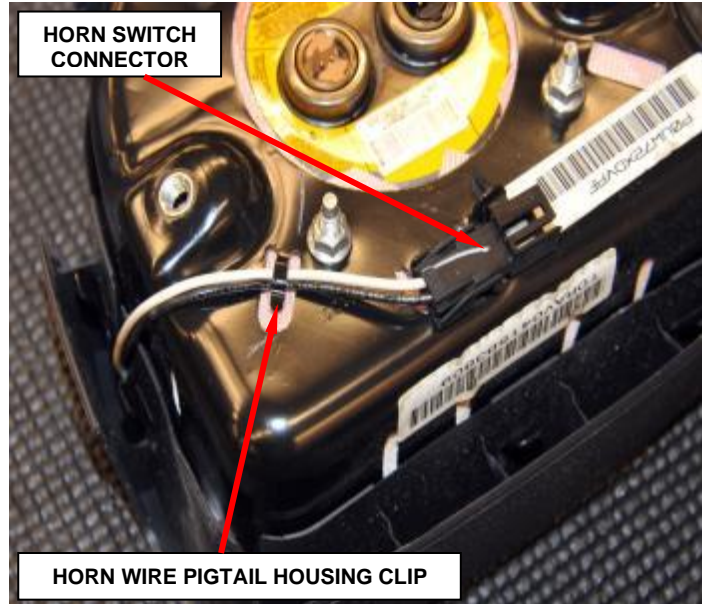
Figure 5 – Horn Connector

9. Place the driver airbag on a soft surface to prevent damage using the foam block provided with the inflator kit.
10. Remove the horn switch connector from the housing (Figure 5).
11. Remove the horn wire pigtail from the housing clip (Figure 5).
12. Remove the driver airbag cover starting with the left side by pressing down on the driver airbag housing until the hooks unsnap from the windows (Figure 6).

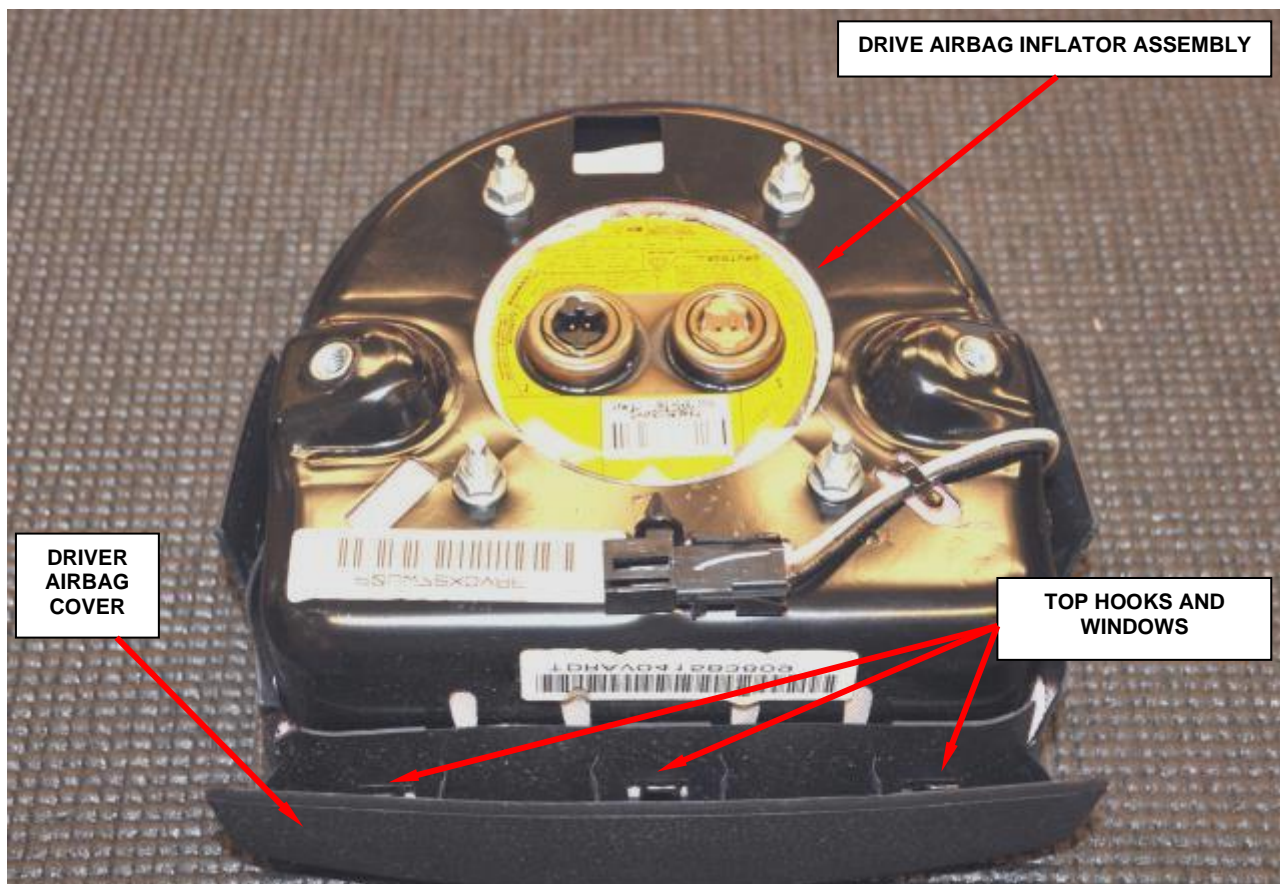
Figure 7 – Driver Airbag Inflator Assembly to Cover

13. Unsnap the bottom hooks by pressing down on the housing until the hooks unsnap from the cover.
14. Unsnap the right side hooks by pressing down on the housing until the hooks unsnap from the cover.
15. Gently pull the housing up slowly making sure that the hooks are clear from the windows on all sides.
16. Disengage the old inflator assembly from the driver airbag cover and set aside for shipping.
17. Install the new inflator assembly to the original driver airbag cover by first inserting the top hooks into the windows (Figure 7).

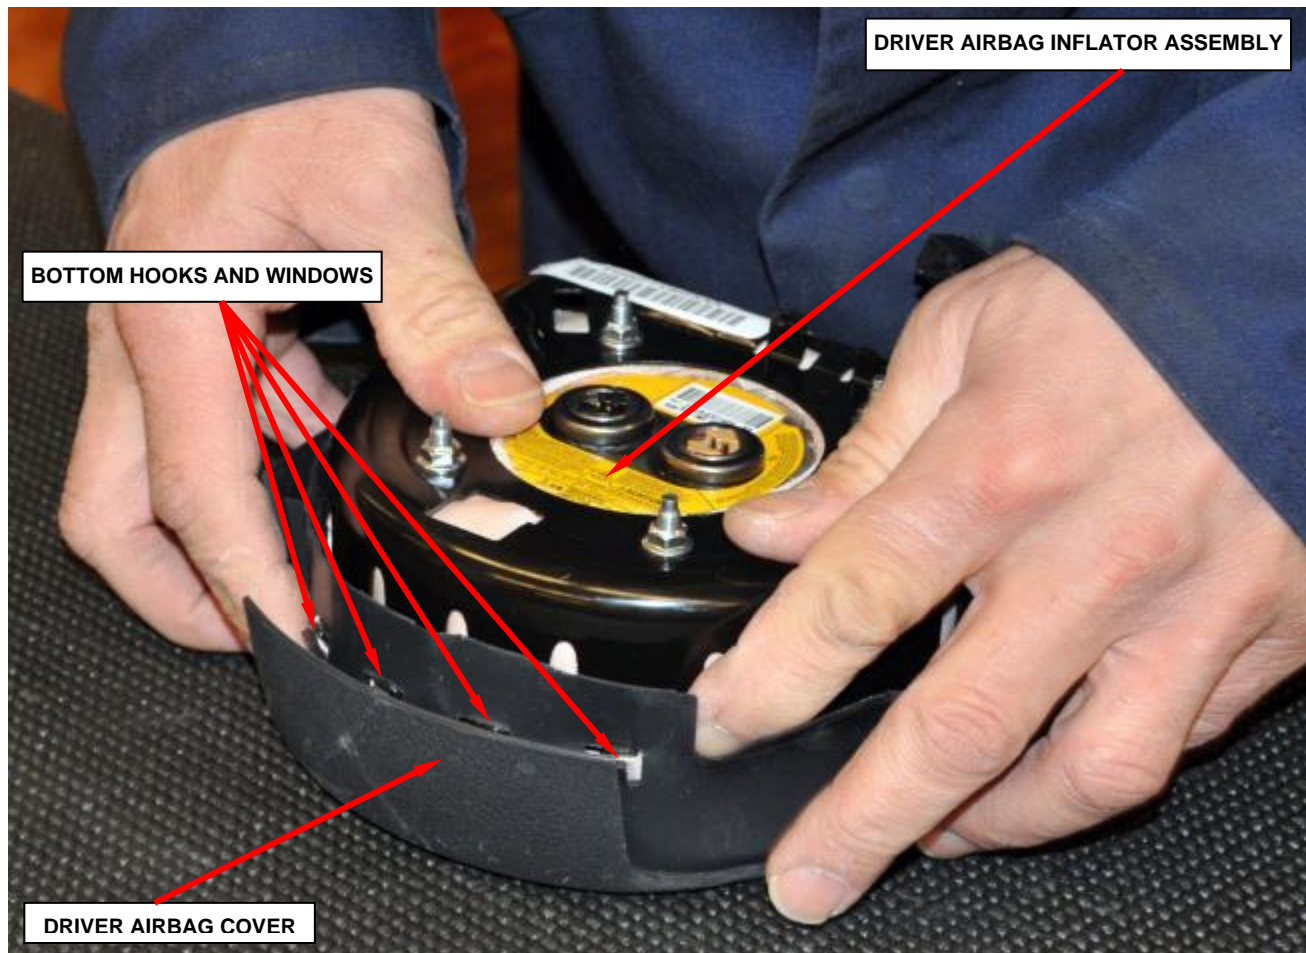
Figure 8 - Verify Hook and Window Engagement

18. Snap the remaining hooks in the windows on all sides into place.
19. Pull on the driver airbag inflator assembly to fully engage the hooks and windows on all sides of the driver airbag cover (Figure 8).

NOTE: Visually inspect and verify that all the hooks are fully engaged with the windows on all sides.

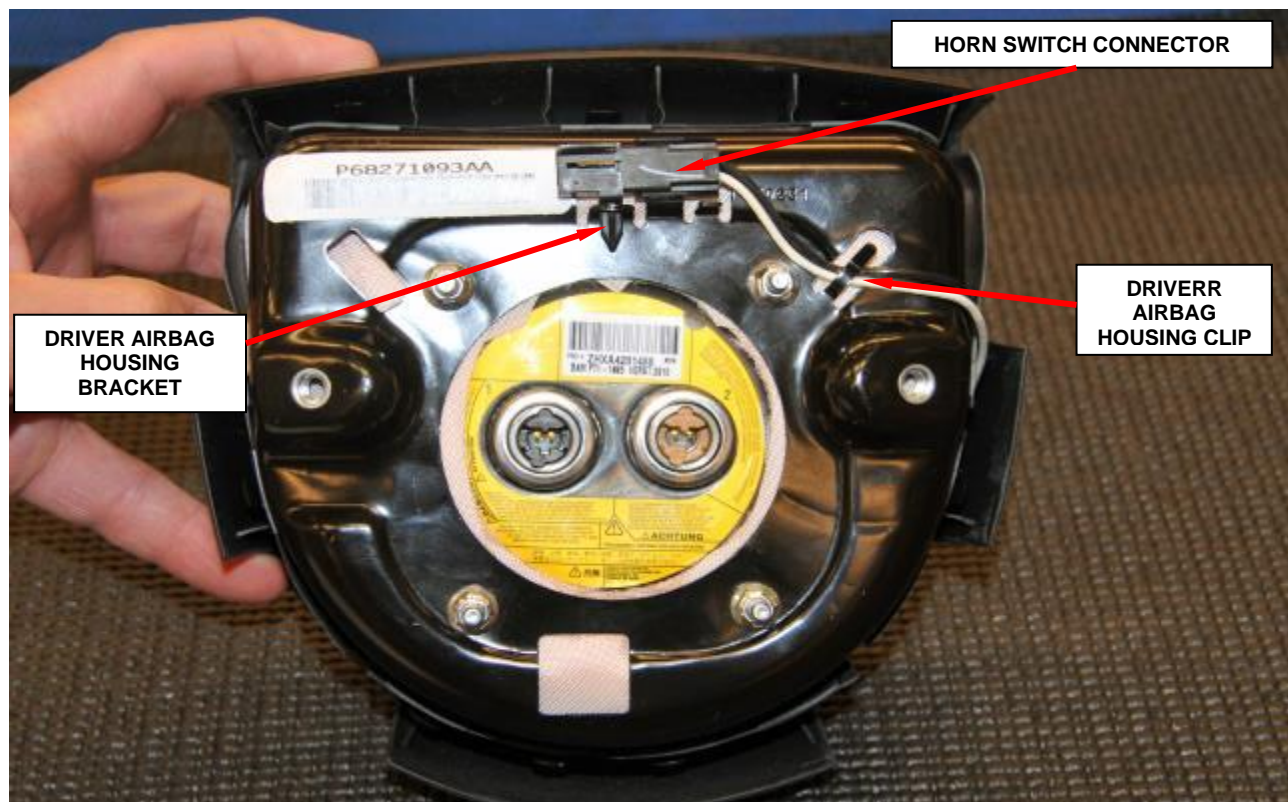
Figure 9 – Horn Switch Connector

20. Clip the horn switch connector to the driver airbag housing bracket (Figure 9).
21. Engage the horn switch wire harness pigtail to the driver airbag housing clip (Figure 9).
22. Driver airbag retrofit is complete (Figure 9).
