**TECHNICAL INSTRUCTIONS**  
**FOR**  
**SAFETY RECALL FOR**  
**SOFTWARE UPDATE FOR MOTOR GENERATOR ECU AND POWER**  
**MANAGEMENT ECU**

**CERTAIN: 2012-2014 PRIUS V**

**UPDATE: 10/11/18 - TI has been updated to specify CID's**

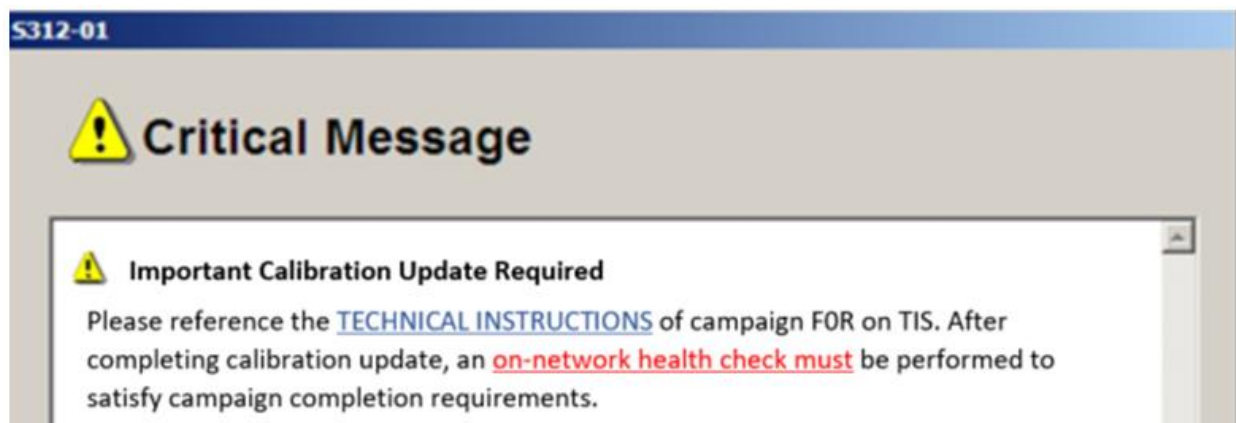
Note: If you receive the following message after the final Health Check, you have not properly completed the Required Calibration Updates!!
