Recall Campaign 15V-450: Side Impact Performance

NEW F56 (Cooper S, JCW Hardtop 2 Door)

Produced from December 2013 to March 2015

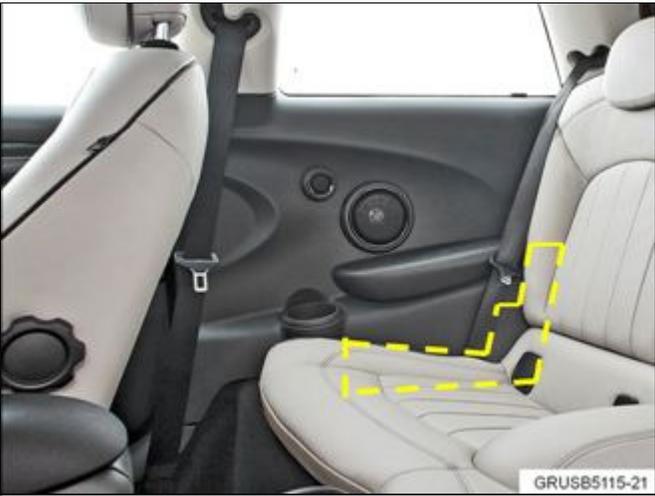
The vehicle's side structure is designed to help absorb energy in the event of a side collision. Due to vehicle build variation, some of the vehicles may marginally exceed a NHTSA test requirement. MINI is performing a voluntary upgrade to these vehicles. Additional energy-absorbing material between the rear interior side panels and the vehicle structure will be added to help enhance occupant protection in the event of a side collision.

<p style="text-align: right; font-size: small;">GRUSB5115-21</p>	<p>Install a molded structural foam pad to both the left and right rear side trim panels.</p> <p>The pad is applied to the inside surface of the panel, and is not visible either from inside the vehicle nor from the outside.</p> <p>The general location is indicated on this passenger side panel by the dotted line.</p>
--	---
