Service Information

M51 03 15

Recall Campaign 15V-450: Side Impact Performance

F56 (Cooper S, JCW Hardtop 2 Door)

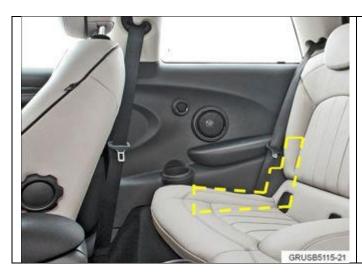
The general location is indicated on this passenger side panel by the dotted line.

Install a molded structural foam pad to both the left and right rear side trim panels.

The pad is applied to the inside surface of the panel, and is not visible either from inside the vehicle nor from the outside.
