SI M51 04 15
Body Equipment

NEW Recall Campaign 15V-450: Side Impact Performance

NEW F56 (Cooper Hardtop 2 Door)

Produced from December 2013 to March 2015

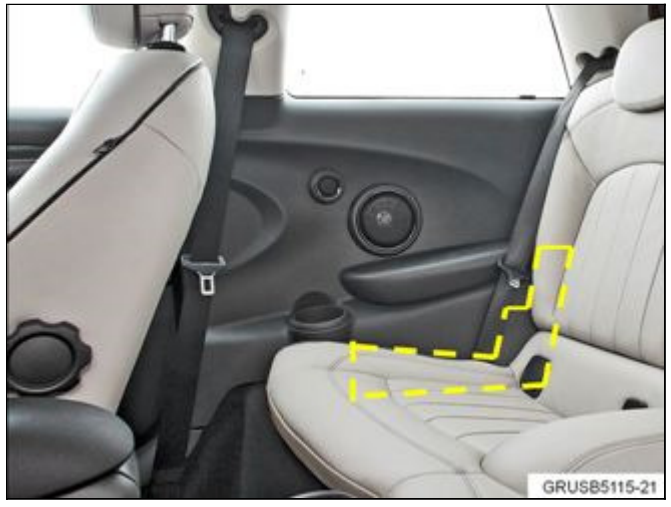
The vehicle's side structure is designed to help absorb energy in the event of a side collision. Due to vehicle build variation, some of the vehicles may marginally exceed a NHTSA test requirement. MINI is performing a voluntary upgrade to these vehicles. Additional energy-absorbing material between the rear interior side panels and the vehicle structure will be added to help enhance occupant protection in the event of a side collision.

<p style="text-align: right; font-size: small;">GRUSB5115-21</p>	<p>Install a molded structural foam pad to both the left and right rear side trim panels.</p> <p>The pad is applied to the inside surface of the panel, and is not visible either from inside the vehicle nor from the outside.</p> <p>The general location is indicated on this passenger side panel by the dotted line.</p>
--	---

Refer to Attachment 1, Repair Instruction 51 43 002, “Removing and installing (replacing) the rear left or right side trim panel.”

Refer to Attachment 2 to modify the side panel and install the structural foam pad.
