This Service Information bulletin supersedes SI M51 03 15 **dated July 2015**.

SUBJECT

Delivery Stop: Side Impact Performance

F56 (Cooper S, JCW Hardtop 2 door)

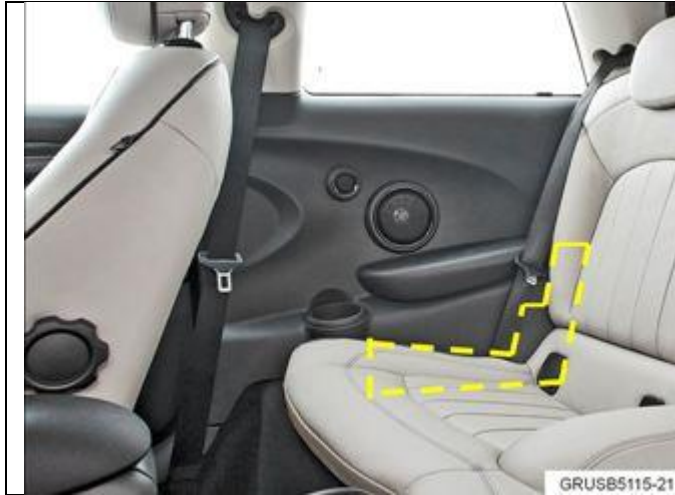
The vehicle's side structure is designed to help absorb energy in the event of a side collision. Due to vehicle build variation, some of the vehicles may marginally exceed a NHTSA test requirement. MINI is performing a voluntary upgrade to these vehicles. Additional energy-absorbing material between the rear interior side panels and the vehicle structure will be added to help enhance occupant protection in the event of a side collision.

The general location is indicated on this passenger side panel by the dotted line.

Install a molded structural foam pad to both the left and right rear side trim panels.

The pad is applied to the inside surface of the panel, and is not visible either from inside the vehicle nor from the outside.
