Recall Campaign 15V-450: Side Impact Performance

F56 (Cooper Hardtop 2 Door)

Produced from December 2013 to March 2015

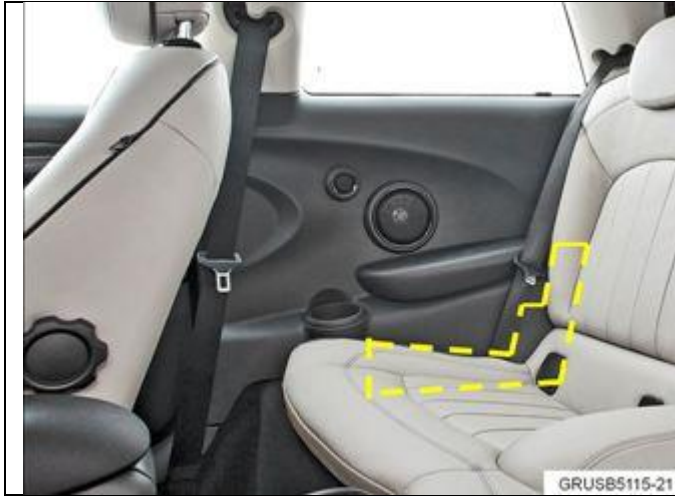
The vehicle's side structure is designed to help absorb energy in the event of a side collision. Due to vehicle build variation, some of the vehicles may marginally exceed a NHTSA test requirement. MINI is performing a voluntary upgrade to these vehicles. Additional energy-absorbing material between the rear interior side panels and the vehicle structure will be added to help enhance occupant protection in the event of a side collision.

The general location is indicated on this passenger side panel by the dotted line.

Install a molded structural foam pad to both the left and right rear side trim panels.

The pad is applied to the inside surface of the panel, and is not visible either from inside the vehicle nor from the outside.
