Delivery Stop: Side Impact Performance

F56 (Cooper Hardtop 2 door)

Produced from July 2014 to March 2015

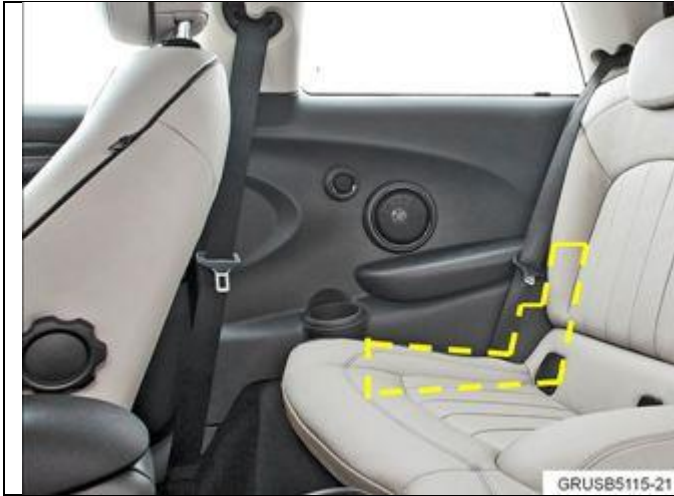
The vehicle's side structure is designed to help absorb energy in the event of a side collision. Due to vehicle build variation, some of the vehicles may marginally exceed a NHTSA test requirement. MINI is performing a voluntary upgrade to these vehicles. Additional energy-absorbing material between the rear interior side panels and the vehicle structure will be added to help enhance occupant protection in the event of a side collision.

The general location is indicated on this passenger side panel by the dotted line.

Install a molded structural foam pad to both the left and right rear side trim panels.

The pad is applied to the inside surface of the panel, and is not visible either from inside the vehicle nor from the outside.
