SI M51 09 14
Body Equipment

Recall Campaign 15V-450: Side Impact Performance

NEW F56 (MINI Cooper Hardtop 2-door)

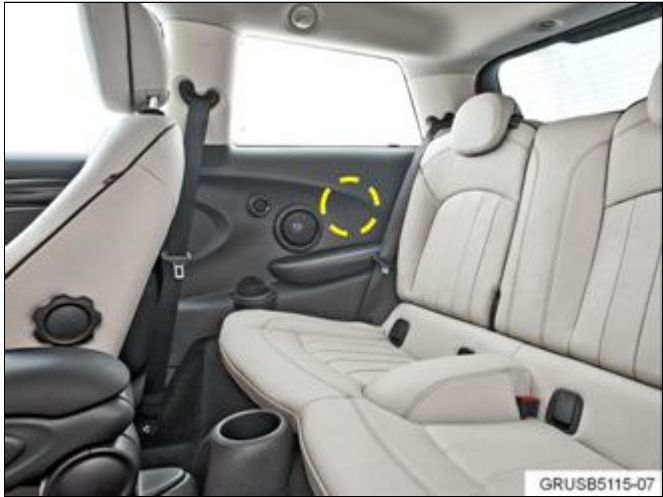
<p>The general area of the repair is circled, with the side panel in position. The passenger side of the vehicle is shown; the driver side is also affected. Remove the rear right and left hand side trim panels per Repair Instructions 51 43 002.</p>
