This Service Information bulletin supersedes SI M51 09 14 **dated February 2015.**

### **Recall Campaign 15V-450: Side Impact Performance**

F56 (MINI Cooper Hardtop 2-door)

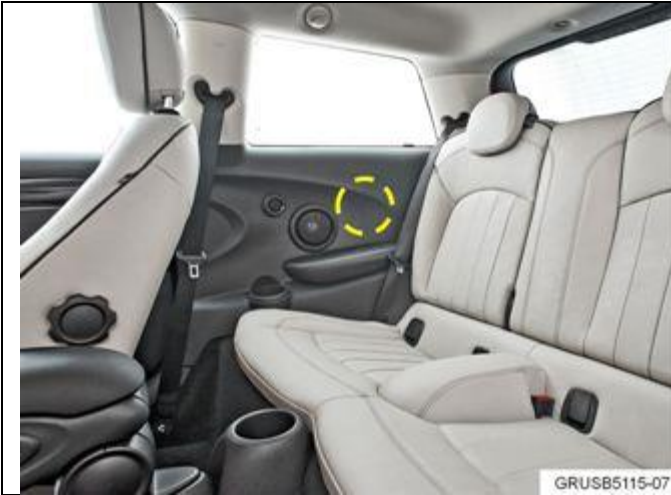
The general area of the repair is circled, with the side panel in position. The passenger side of the vehicle is shown; the driver side is also affected.

Remove the rear right and left hand side trim panels per Repair Instructions 51 43 002.
