Recall Campaign 15V-450: Side Impact Performance

F56 (MINI Cooper S Hardtop 2-Door)

Model Year 2014

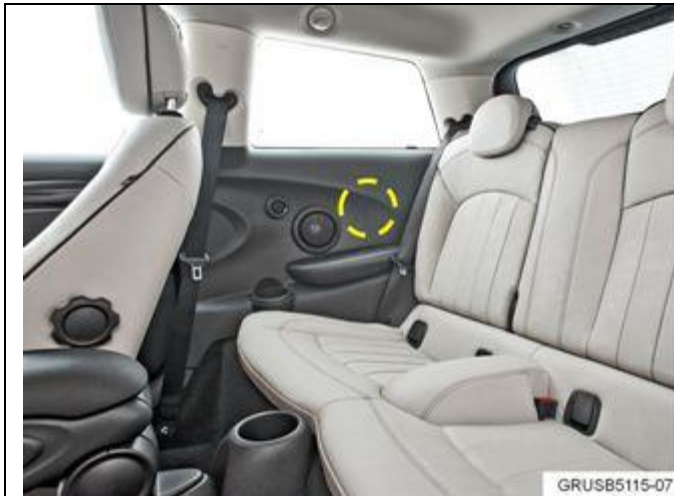
- The general area of the repair is circled, with the side panel in position. The passenger side of the vehicle is shown; the driver side is also affected.
- Remove the rear right and left hand side trim panels per Repair Instructions 51 43 002.
