Recall Campaign 15V-450: Side Impact Performance

NEW F56 (MINI **Cooper S** Hardtop 2-Door)

Model Year 2014

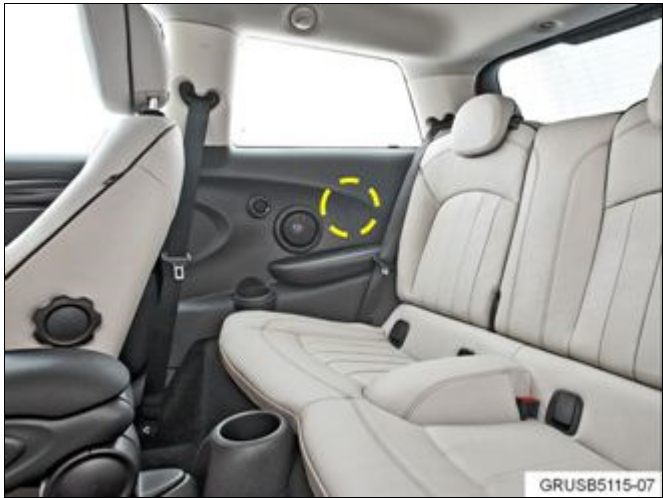
<p style="text-align: right; font-size: small;">GRUSB5115-07</p>	<ul style="list-style-type: none"> • The general area of the repair is circled, with the side panel in position. The passenger side of the vehicle is shown; the driver side is also affected. • Remove the rear right and left hand side trim panels per Repair Instructions 51 43 002.
--	--
