TO: All Mazda Dealership General Managers, Service Managers, and Parts Managers
DATE: September 2015
SUBJECT: **2007-2014 CX-9 Front Lower Control Arms - Safety Recall 8515G**

2007-2014 CX-9 - FRONT LOWER CONTROL ARMS - SAFETY RECALL 8515G

**2007-2014 CX-9
Front Lower Control Arms Safety Recall 8515G
NHTSA Campaign No. 15V-451**

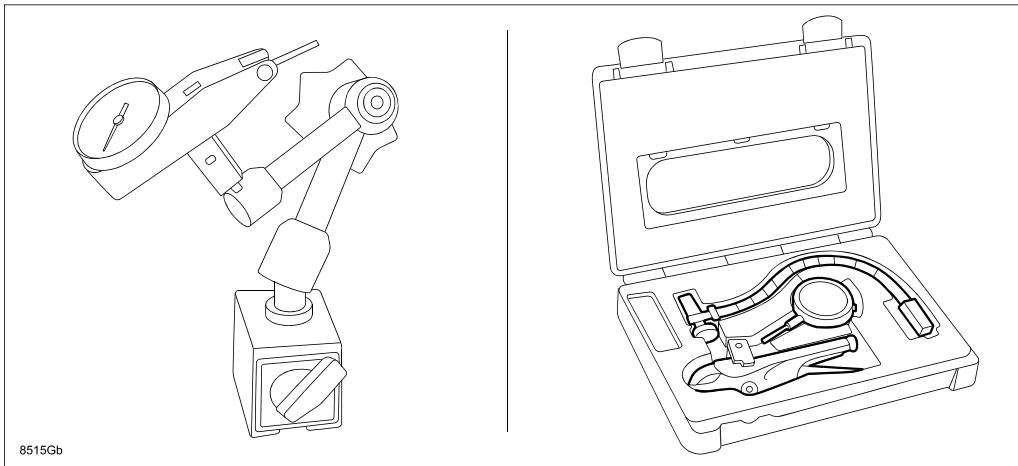
1. Obtain one of the following tools to measure the lower control arm play.

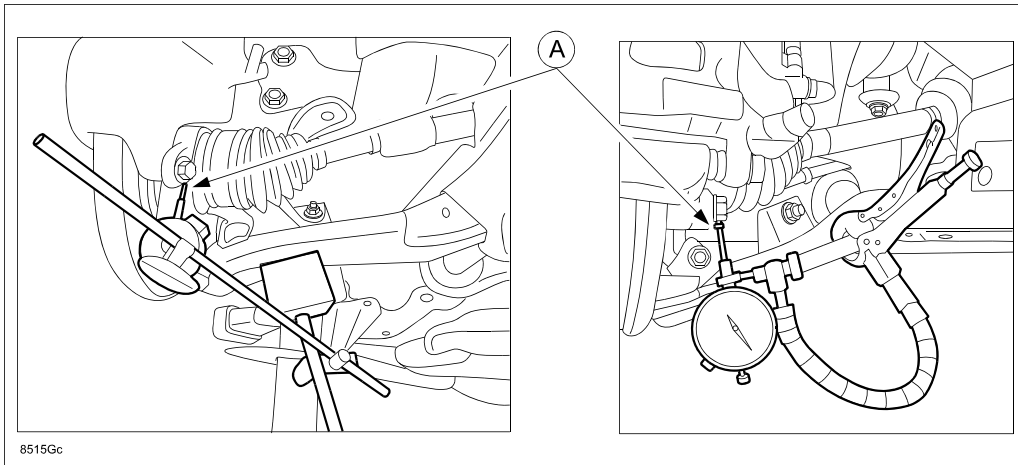
2. Fix a magnetic base or locking pliers to the bottom of the lower control arm (to set the dial gauge).
3. Place the sensing tip of the dial gauge on the horizontal flat surface of the bolt hexagonal head (A) (which attaches the brake caliper to the steering knuckle).

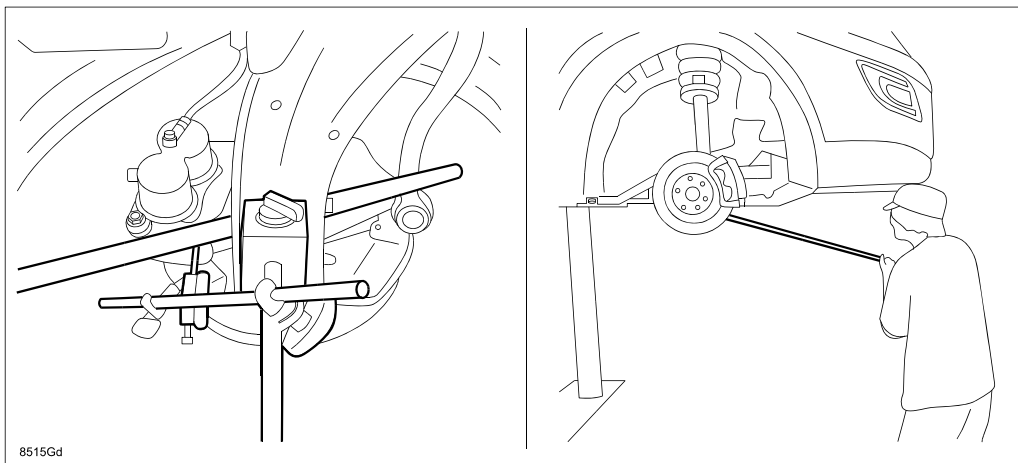
4. Press down on the lower control arm with a pry bar or metal bar (ex. 4 foot long jack handle).

5. Measure the play of the ball joint with the dial gauge.

Acceptable play amount: **Under 2.0 mm {0.079 (5/64) in.}**

- If both ball joints pass inspection, inform the customer that they will still need to bring their vehicle back to replace the lower control arms once they receive another notification informing them that the repair parts are available.
- If one or both ball joints fail inspection, proceed to "C. REPAIR PROCEDURE" to replace both lower control arms and spacers.

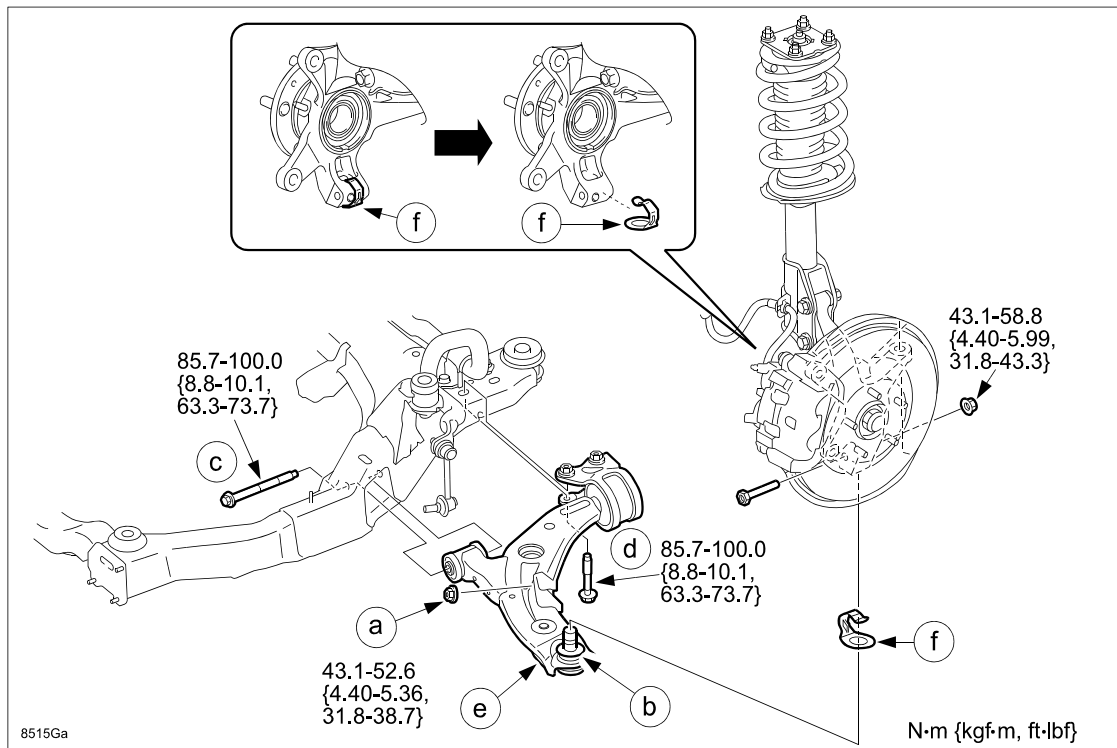
1. Safely raise the vehicle on a hoist.
2. Remove both front wheels.
3. Remove the front lower arm in the order indicated below (a - e):

NOTE: It is NOT necessary to disconnect the ABS wheel-speed sensors and tie-rod end ball joints.

- a. Disconnect the stabilizer control link (lower arm side).
- b. Remove the lower arm ball joint attaching nuts.
- c. Remove the attaching bolt between the lower arm and body (front side).
- d. Remove the attaching bolt between lower arm and body (back side).
- e. Remove the lower arm.

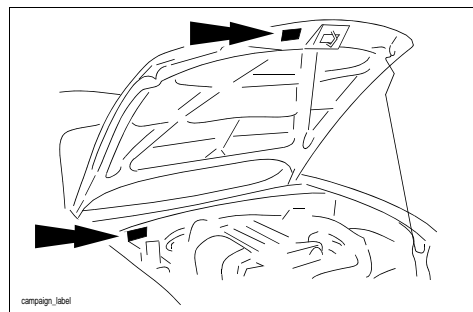
2. Affix it to the hood or bulkhead as shown:
