# Safety Recall

## Code: 48M1

<b>Subject</b>	<b>Power Steering Assist Software</b>
<b>Release Date</b>	July 21, 2015
<b>Affected Vehicles</b>	<b>U.S.A. &amp; CANADA: 2014-2015 MY Audi SQ5</b> <i>Check Campaigns/Actions screen in Elsa on the day of repair to verify that a VIN qualifies for repair under this action. Elsa is the <u>only</u> valid campaign inquiry &amp; verification source.</i> <ul style="list-style-type: none"><li>✓ Campaign status must show "open."</li><li>✓ If Elsa shows other open action(s), inform your customer so that the work can also be completed at the same time the vehicle is in the workshop for this campaign.</li></ul>
<b>Problem Description</b>	The affected vehicles have electric power steering assist systems that may shut down as a result of a steering motor sensor fault (which could only occur with very cold ambient temperatures). If the vehicle experiences a loss of power steering assist, extra steering effort will be required at lower speeds, increasing the risk of a vehicle crash.

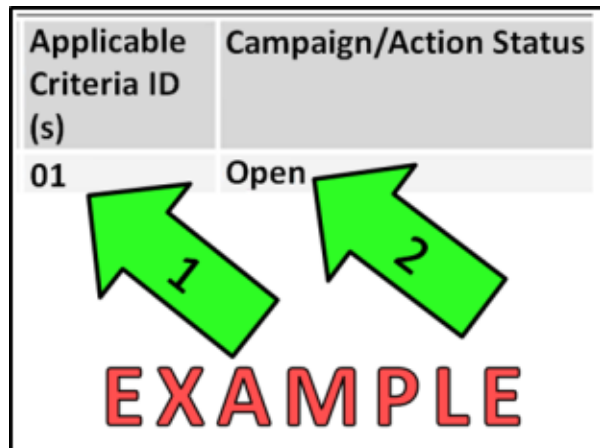
**EXAMPLE**

- Ensure that the Status is “Open” <arrow 2>.
- Note the Applicable Criteria ID <arrow 1> for use in determining the correct work to be done and corresponding parts associated.

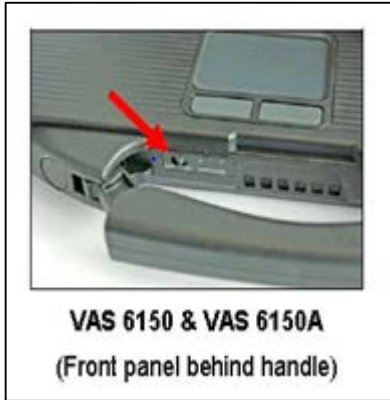
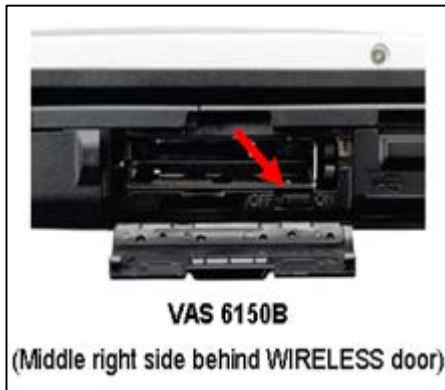
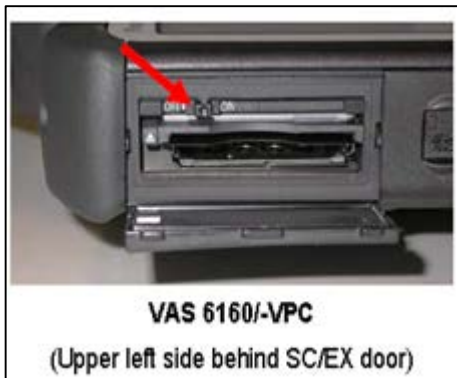
The Bluetooth function of the scan tool **MUST BE PHYSICALLY SWITCHED OFF** prior to performing this update. <See pictures>

- Open the hood.
- Attach an appropriate battery charger to the vehicle battery.
- Attach the scan tool to the vehicle.
- From the home screen of the scan tool select Flash.
- Follow the on-screen prompts.
- Select "SVM code input".
- Enter SVM code **48M1A416**.
- Follow the on-screen prompts.
- Close the hood.
