Dealer Service Instructions for:

Safety Recall R36 / NHTSA 15V-459

Steering Wheel Wiring

2012 – 2014	(DS) RAM 1500 Pickup
2012 – 2014	(DJ) RAM 2500 Pickup
2012 – 2014	(D2) RAM 3500 Pickup
2012 – 2014	(DD) RAM 3500 Cab Chassis
2012 – 2014	(DP) RAM 4500/5500 Cab Chassis

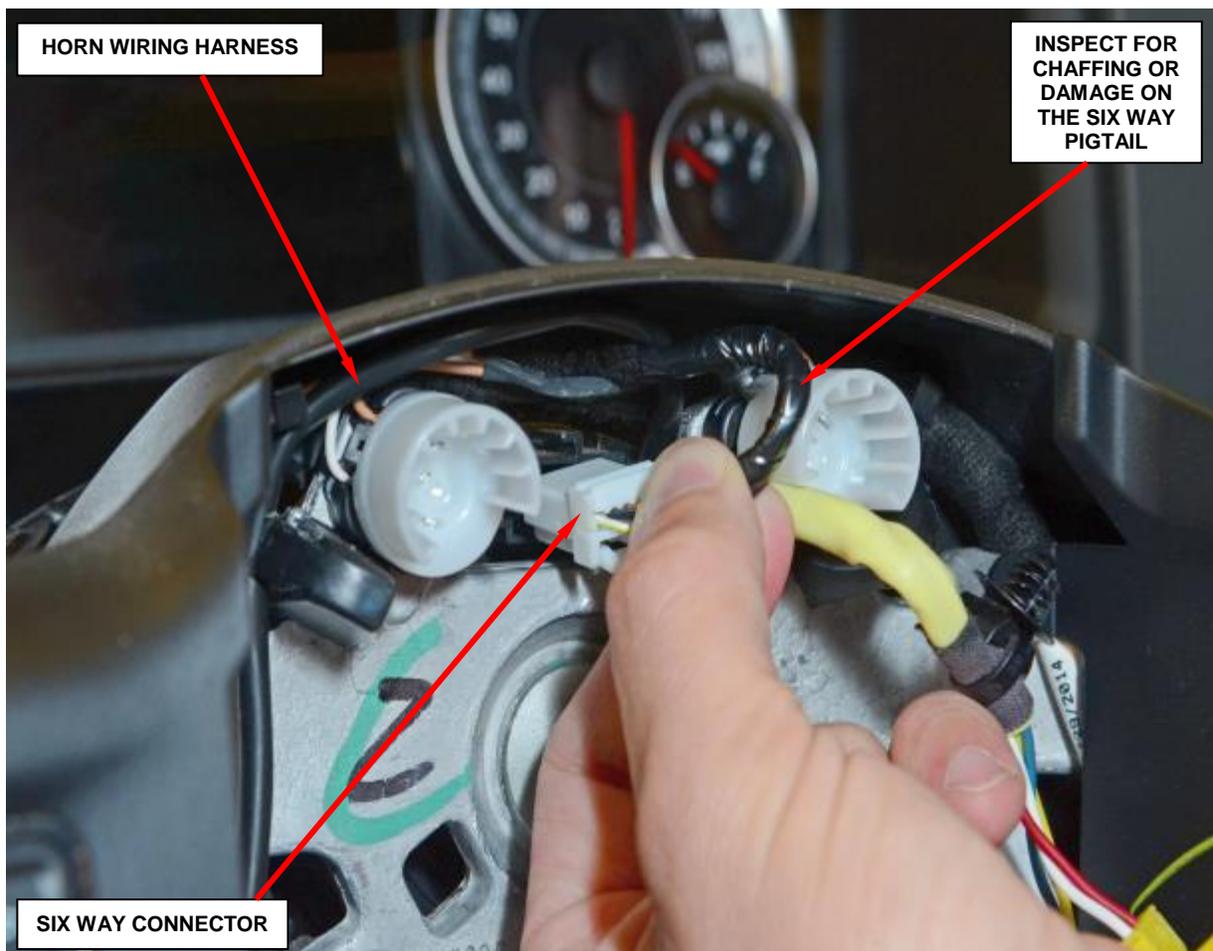
Figure 4 – Inspect For Wire Pigtail Damage

12. Inspect the wiring harness for chaffing or damage on the six way pigtail and repair as necessary (Figure 4).

NOTE: If bare wire or chaffing is present, tape the wire using vinyl electrical tape.
