Revised September 2015

Dealer Service Instructions for:

Safety Recall R36 / NHTSA 15V-459

Steering Wheel Wiring

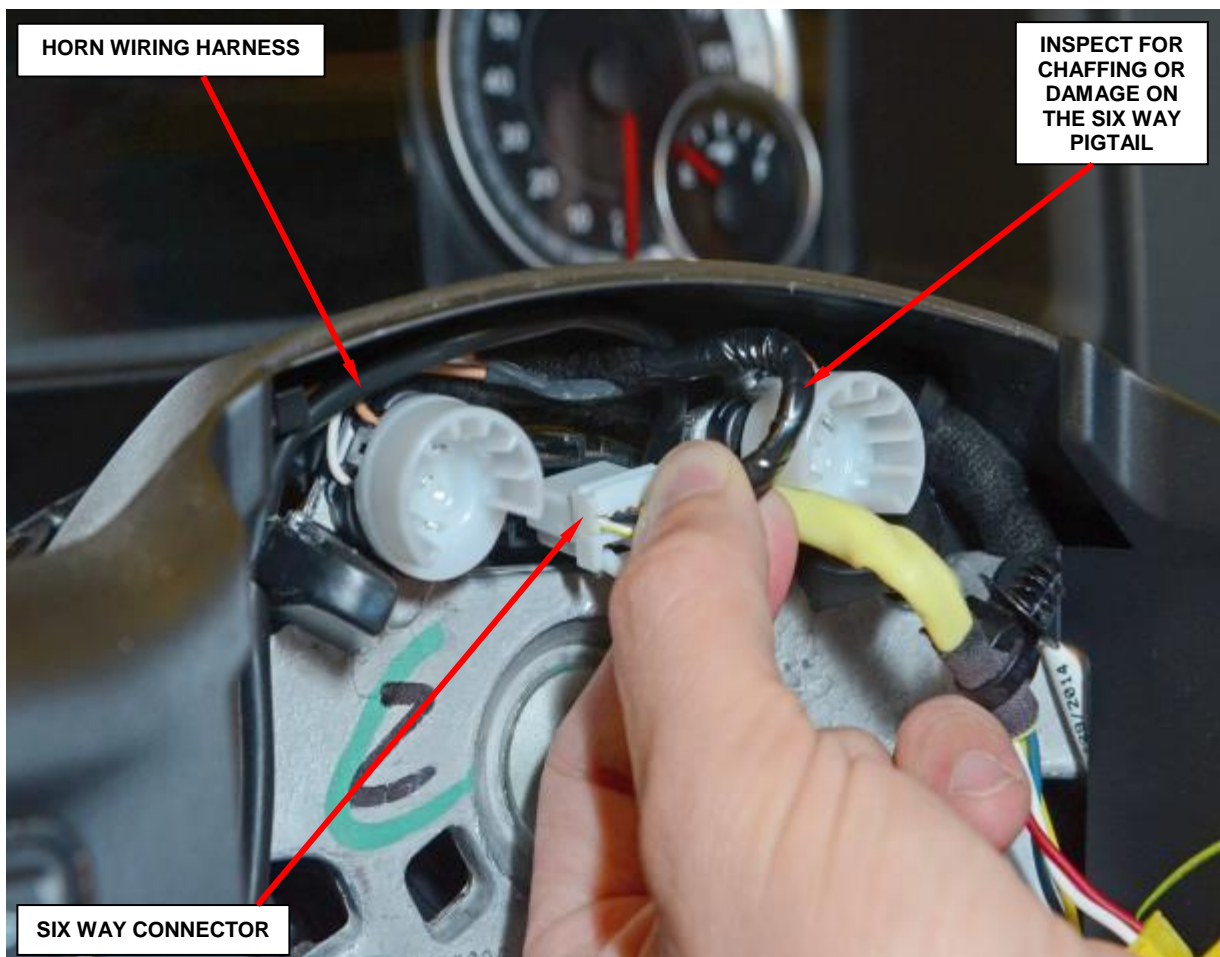
Figure 4 – Inspect For Wire Pigtail Damage

12. Inspect the wiring harness for chaffing or damage on the six way pigtail and repair as necessary (Figure 4).

11. Disconnect the steering wheel wire harness six way connector (Figure 4).

NOTE: If bare wire or chaffing is present, tape the wire using vinyl electrical tape.
