Revised September 2015

Dealer Service Instructions for:

# **Safety Recall R40 / NHTSA 15V-461**

## **Radio Security Vulnerability**

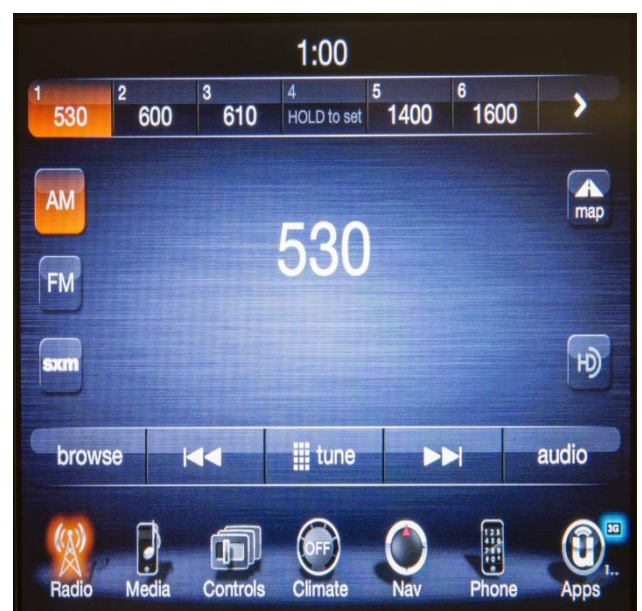
**Figure 1 – Select “Controls”**

4. On the 8.4-inch radio touchscreen, select “Controls” (Figure 1),

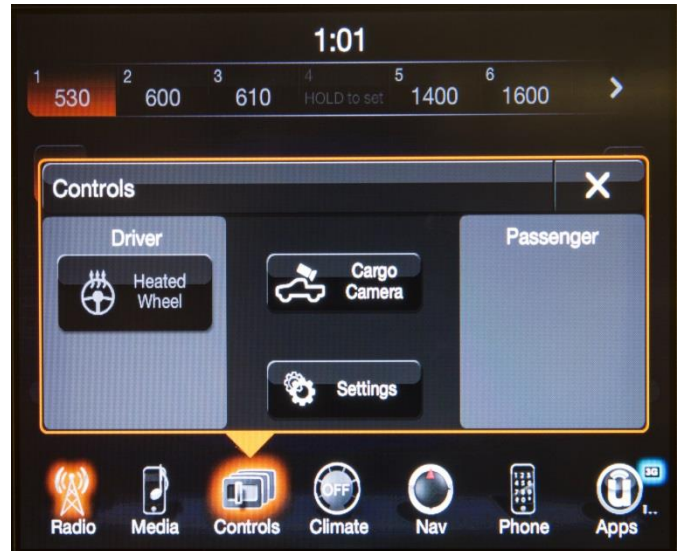
Figure 2 – Select “Settings”

5. Select “Settings” (Figure 2).

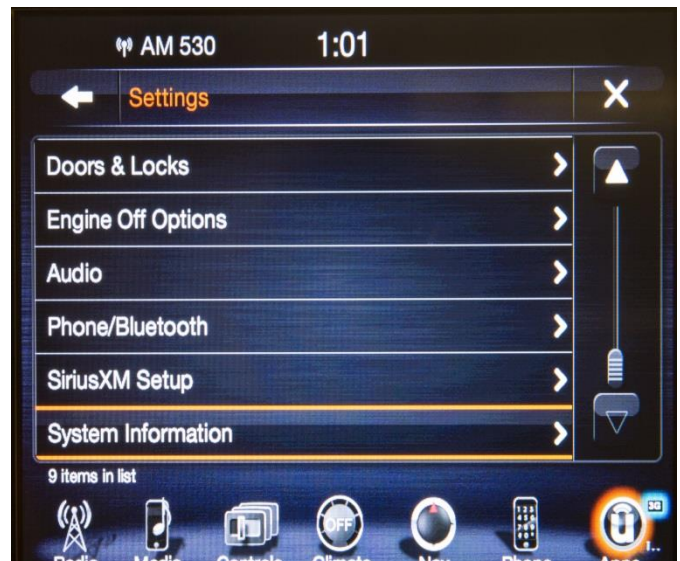
Figure 3 – Select “System Information”

6. Scroll down and select “System Information” (Figure 3).

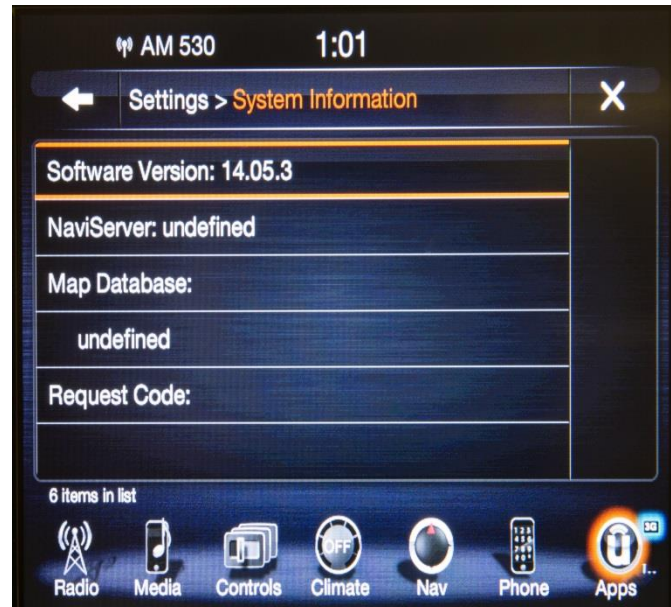
**Figure 4 – Read “Software Version”**

7. Read the “Software Version” to verify the current software version to determine if, and how to proceed (Figure 4).

➤ **For 2015 model year vehicles**, if the current radio software is at 15.17.5 or higher, no further action is required. If the current radio software is lower than 15.17.5, proceed to Step 8.

➤ **For 2013 through 2014 model year vehicles**, if the current radio software level is at 15.26.1 or higher, no further action is required. If the current radio software level is lower than 15.26.1, proceed to Step 8.

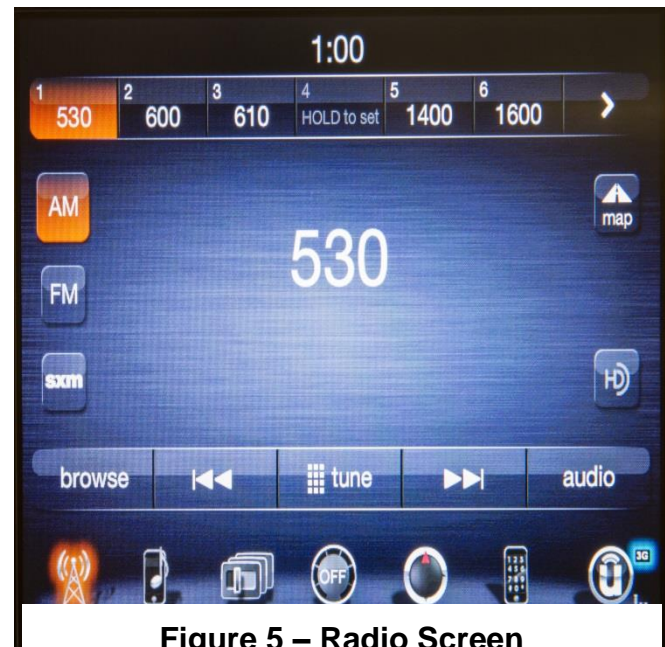
**Figure 5 – Radio Screen**

8. With the engine running and the touchscreen on, insert the USB drive into the Media Hub (Figure 5).

**NOTE: The Media Hub is located:**

- RAM Trucks - In the center console lid compartment
- Dodge Durango - In the cubby under radio, in front of shifter center console
- Jeep Grand Cherokee - In the cubby under radio, in front of shifter center console
- Dodge Viper – In the back panel between driver & passenger seats, above cup holders
- Dodge Challenger – In the In center console
- Dodge Charger - In the center console
- Chrysler 200 – In the center console, after sliding back cup holder
- Chrysler 300 - In the center console storage bin.

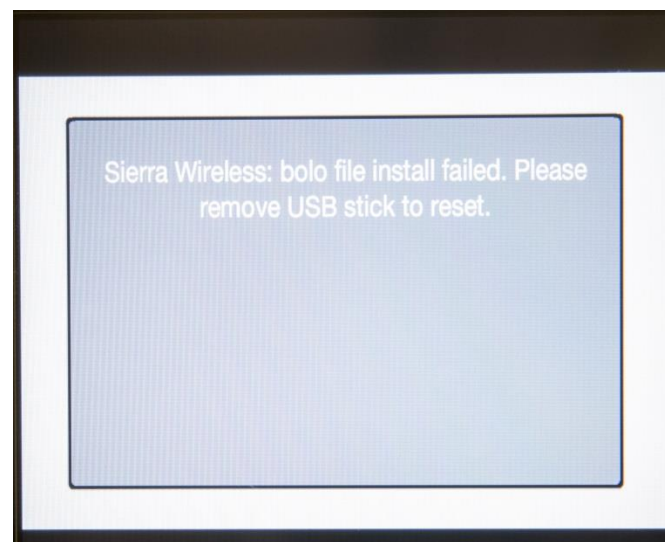
**Figure 6 – Error Condition**

In some cases, the software update procedure may result in an Error Condition during the process. If this occurs, the following steps should be taken to recover and complete the software update procedure.

- If the screen in figure 6 appears on the touch screen, remove the USB drive from the Media Hub.

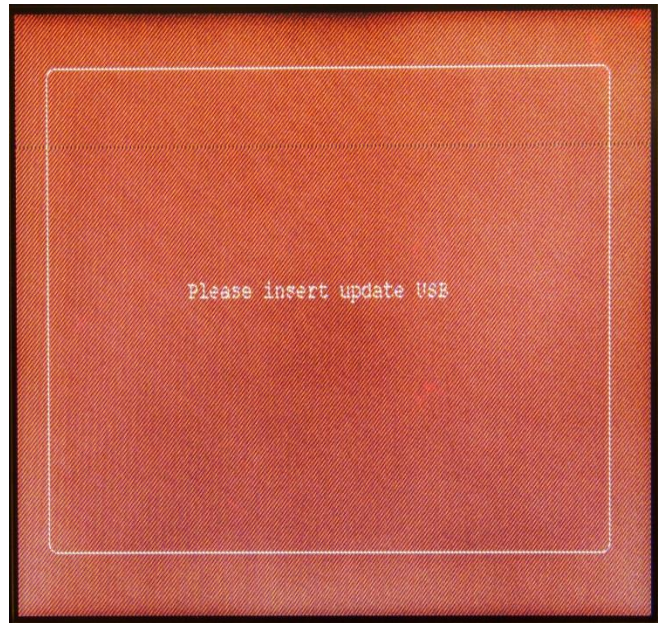
**Figure 7 – Recovery Process**

b. After you remove the USB drive, the touchscreen will show several changes in screen color as part of the recovery process. This is part of the normal recovery process sequence. (Figure 7)

d. Next, re-insert the same USB drive included in this mailing, into the Media Hub USB port. The software will resume automatically.

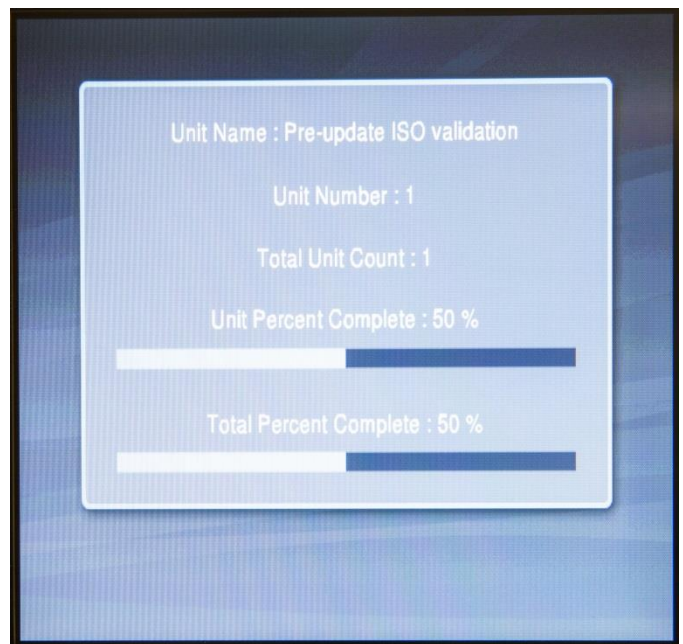
**Figure 8 – “Unit Number 1” Displays**

e. Please watch the status of the progress bar. When the screen displays “Unit Number 1”, **REMOVE THE USB DRIVE** from the Media Hub (Figure 8).

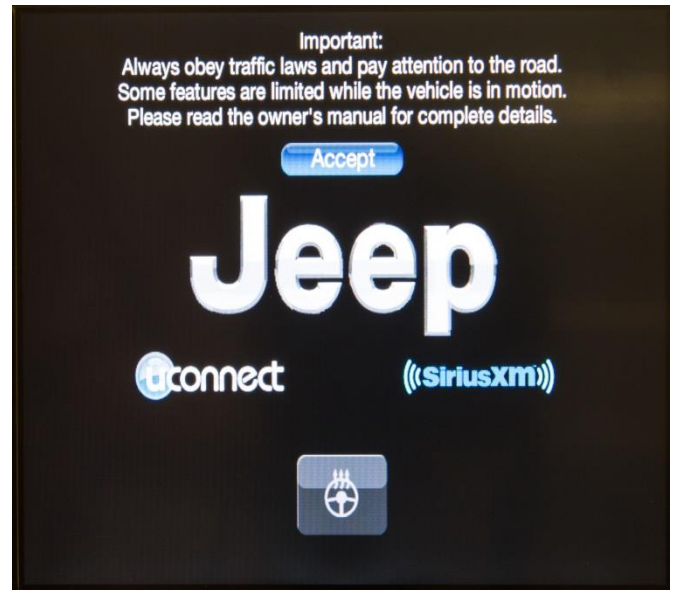
**Figure 9 – Uconnect Start-up Screen**

- g. The radio system will turn off, and restart automatically, and the Uconnect start-up screen will appear. (Figure 9).

- h. When the next screen displays the comparison of the current and new software levels again, press “YES” to continue the update process.
