## **Safety Recall R45 / NHTSA 15V-508 Radio Security Vulnerability**

**2015 (BU) Jeep® Renegade**

*NOTE: This recall applies only to the above vehicles equipped with a Uconnect 6.5" screen radio (sales code RA4) built through July 25, 2015 (MDH 072500).*

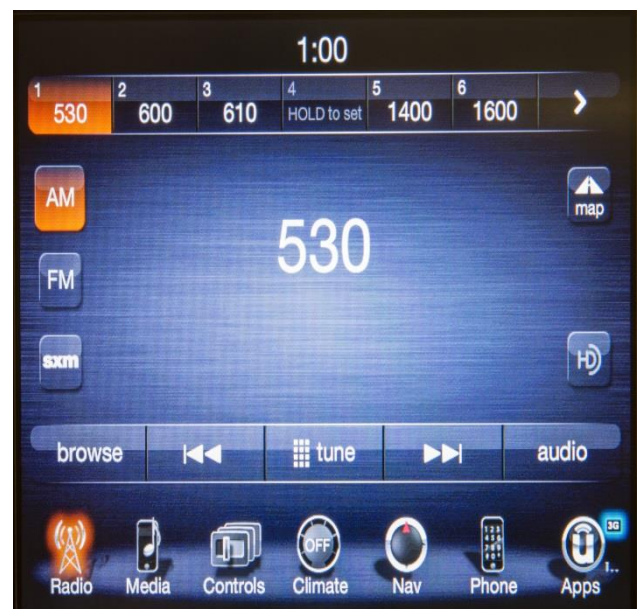
**Figure 1 – Select “Controls”**

2. Apply the parking brake to ensure there is no unintended vehicle movement.
3. Start the engine.
4. On the 6.5-inch radio touchscreen, select “Controls” (Figure 1),

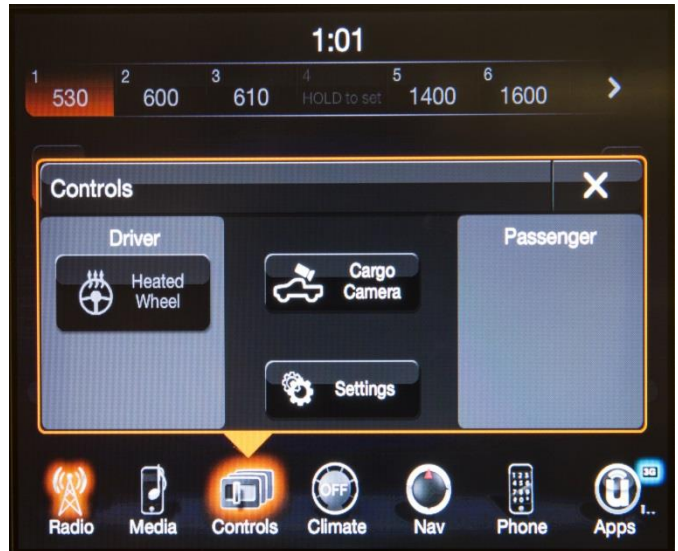
Figure 2 – Select “Settings”

5. Select “Settings” (Figure 2).

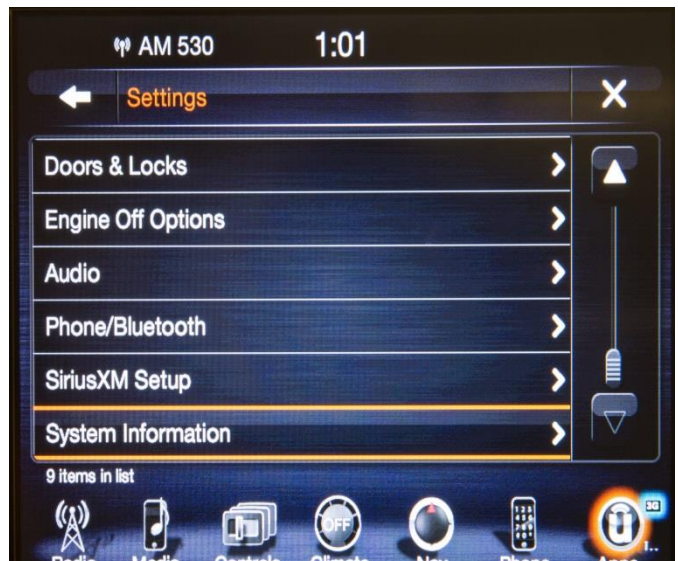
Figure 3 – Select “System Information”

6. Scroll down and select “System Information” (Figure 3).

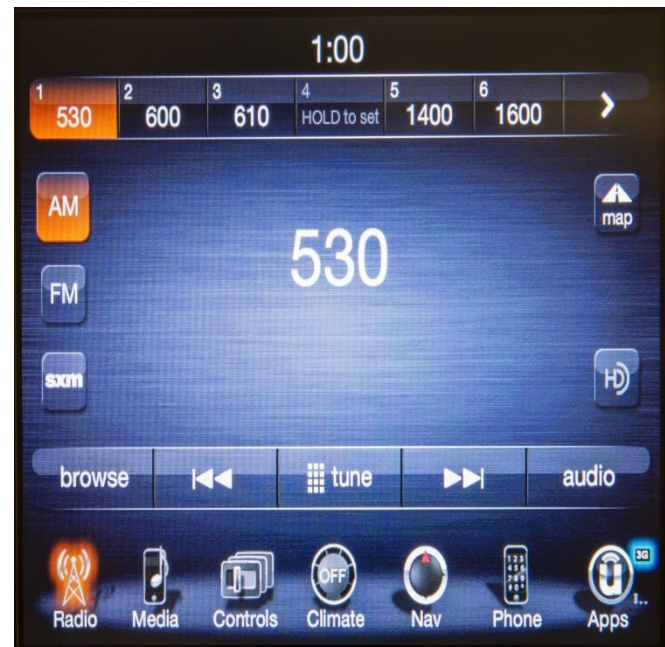
**Figure 5 – Radio Screen**

8. With the engine running and the touchscreen on, insert the USB drive into the Media Hub located in the center console (Figure 5).

**CAUTION:** There is a USB port in the center console storage bin. Do not use this port to update the radio. Other Media ports in the vehicle which supply a charge for devices will not accept the software update.
