October 2015

Dealer Service Instructions for:

## **Safety Recall R43 / NHTSA 15V-517 Battery Wire Harness**

#### **2014 (DS) RAM Trucks (1500 series)**

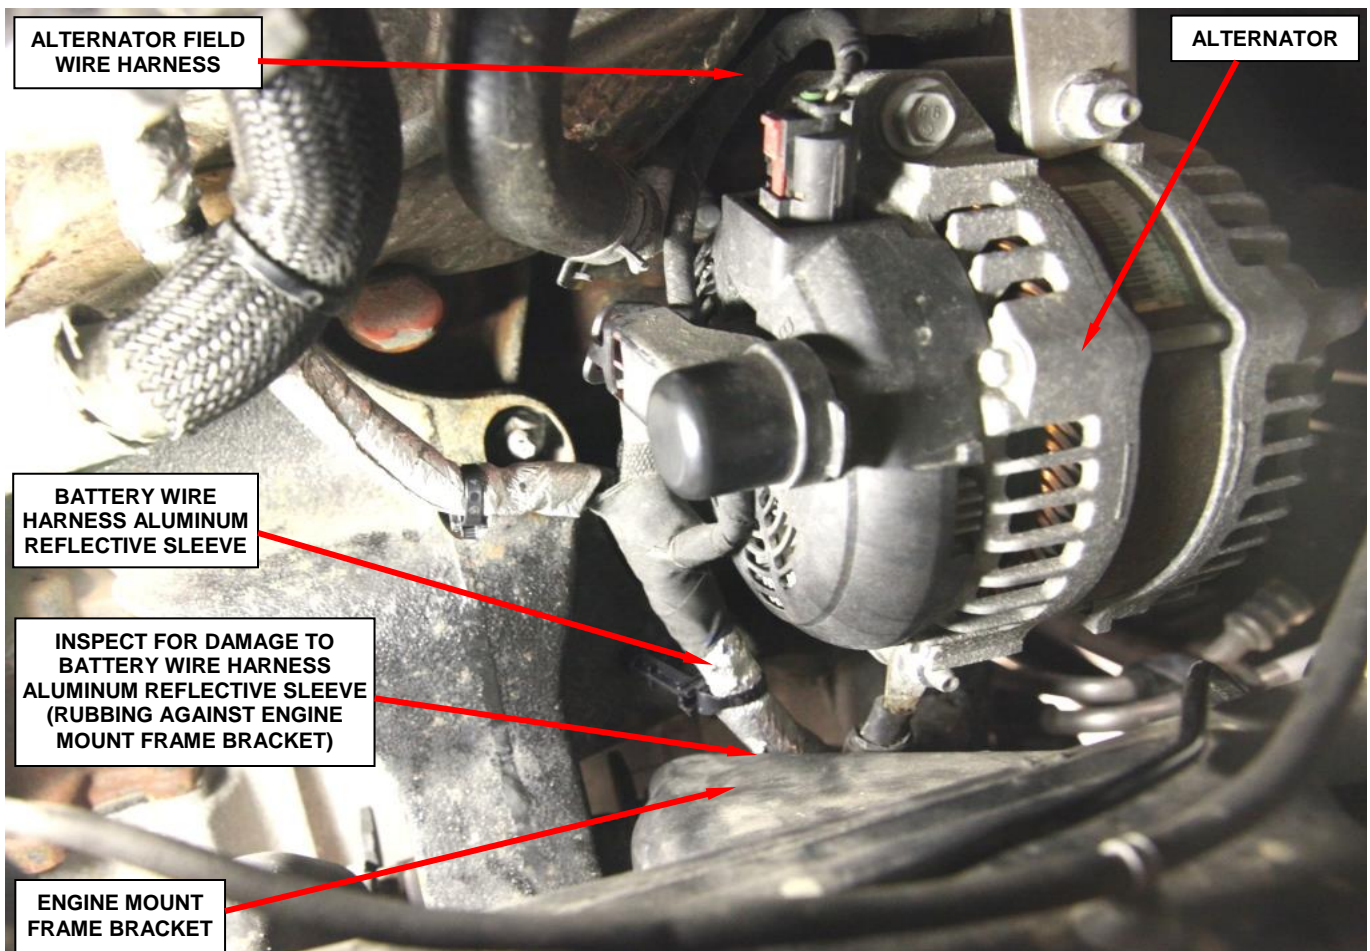
**Figure 1 – Inspect Wire Harness for Damage at Engine Mount Frame Bracket**

The battery (B+) wire harness on about 1,650 of the above vehicles may have been routed against the right engine mount frame bracket. Continuous battery wire harness contact with the right engine mount frame bracket could cause the battery wire harness sheathing to wear and create a high resistive short circuit. A high resistive short circuit could cause the vehicle to stall and/or an underhood electrical fire.

1. Lift the vehicle on an appropriate hoist.
2. Remove and save the right tire/wheel assembly.
3. Remove and save the right front wheel opening plastic liner.
4. Inspect for battery wire harness contact at the engine mount frame bracket (Figure 1):
  - If there is no rub through of the aluminum reflective sleeve, continue with Step 5 of this procedure.
  - If there is a rub through of the aluminum reflective sleeve, continue with **Section B. Replace Engine Wire Harness.**

The battery wire harness must be inspected for a rub through of the wire harness. Trucks found with a damaged battery wire harness must have the battery wire harness replaced. Trucks found with no damage to the battery wire harness will have new battery wire harness routing clips installed. All involved trucks will receive revised battery wire harness routing to eliminate battery wire harness contact with the right engine mount frame bracket.
