# SAFETY RECALL

Mack Trucks Inc.  
Greensboro, NC USA

Number  
**SC0393**

## Air Line and Wiring Harness Routing

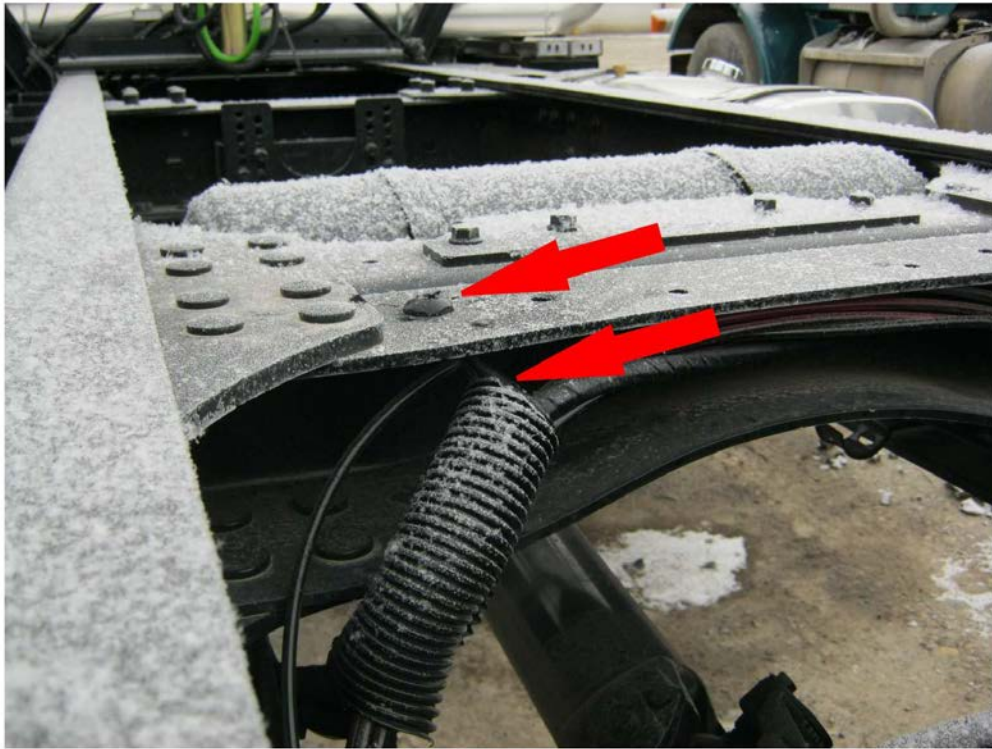
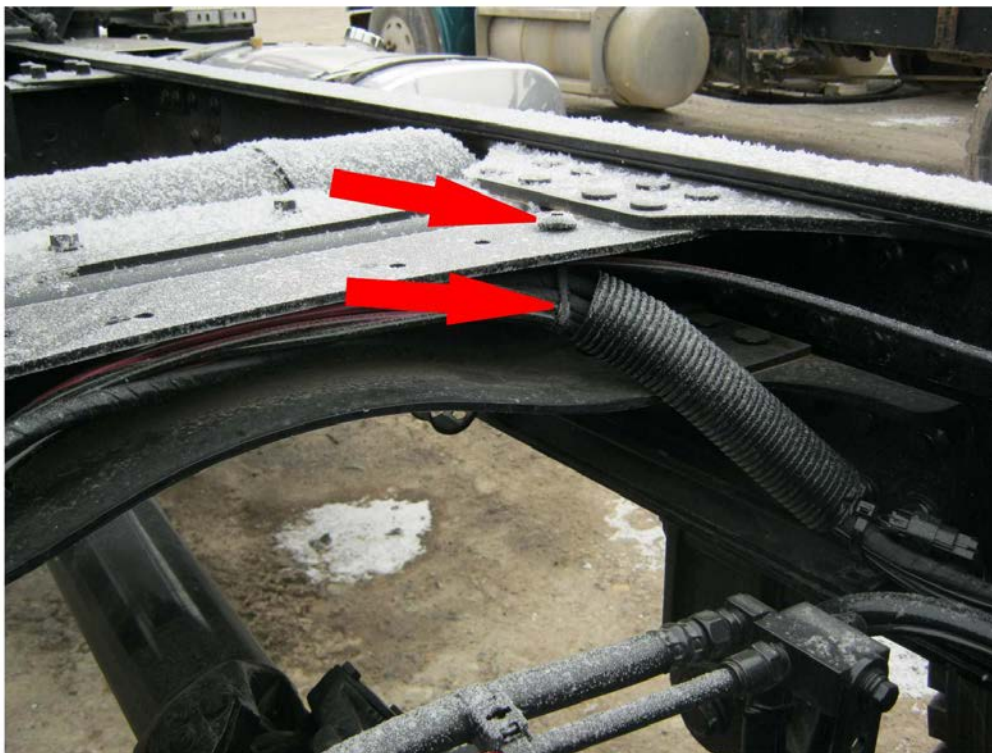
Inspect the routing of the air line bundle and chassis wiring harness. If the air line bundle and chassis harness are secured to a standoff bracket and clamps no further action is required. If they are secured with button head ties proceed with the following steps.

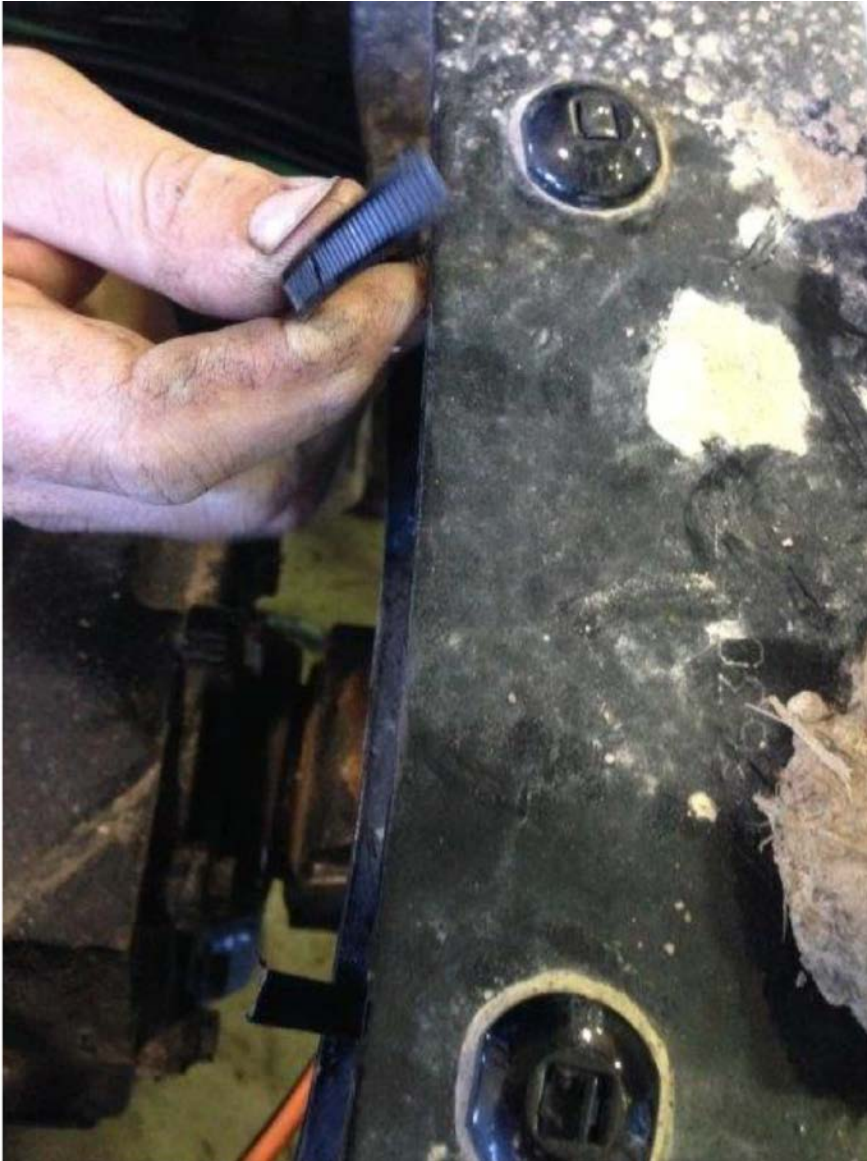
4. Remove the button ties securing the air line bundle and wiring harness to the cross member front and rear.

5. Install the standoff brackets (25626162) to the cross member using flange screws (995487) and lock nuts (990951) into the existing holes where the button head ties were located. Tighten to  $48 \pm 8$  Nm ( $35 \pm 6$  lb-ft).
6. Insert cable ties (25155686) to the standoff brackets.
7. Route the bundle to the standoff brackets and secure using the ties.
8. Reconnect all previously removed cables to the negative (ground) battery terminals.
