January 2016

# **Safety Recall R42 / NHTSA 15V-542 Transmission Control Module**

**2013 - 2015 (PF) Dodge Dart**

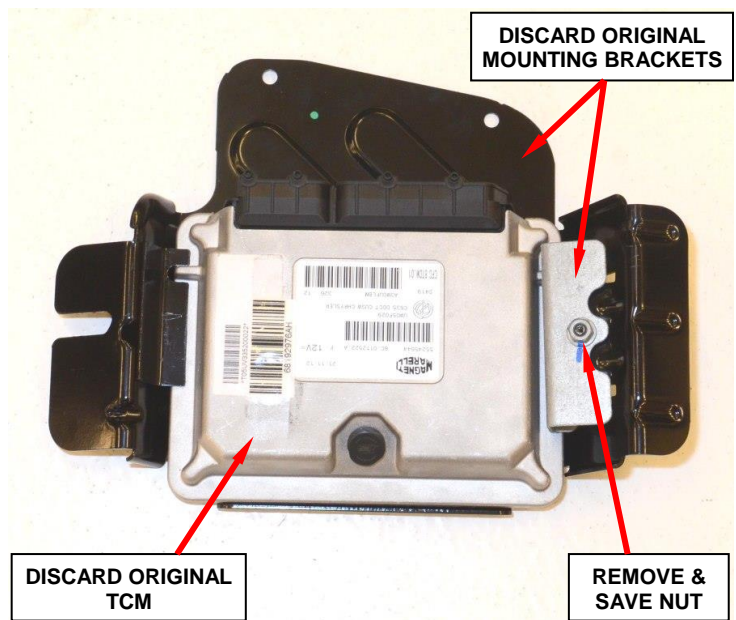
Figure 3 – Original TCM Mounting Bracket and Nut

The Transmission Control Module (TCM) mounting bracket on about 23,500 of the above vehicles may cause the printed circuit board solder joints to separate, resulting in an electrical open circuit in the TCM. An open circuit in the TCM could cause the transaxle to shift into “Neutral” without warning. Having the transaxle unintentionally shift into “Neutral” under certain driving conditions could cause a crash without warning.

12. Remove and save the nut securing the TCM to the mounting bracket (Figure 3).
13. Discard the original TCM and mounting bracket (Figure 3).
14. Place the new TCM in position on the new mounting bracket.
15. Install the new TCM retaining bracket and retaining nut to the mounting bracket stud. Tighten the nut to 62 in. lbs. (7 N·m) (Figure 4).
