SAFETY RECALL BULLETIN

SUBJECT: RIGHT PARKING BRAKE CABLE INTERFERENCE WITH FUEL TANK – SAFETY RECALL CAMPAIGN			No: SR-15-009
			DATE: October, 2015
			MODEL: 2014-15 Lancer RAE and Lancer Evolution
CIRCULATE TO:	<input checked="" type="checkbox"/> GENERAL MANAGER	<input checked="" type="checkbox"/> PARTS MANAGER	<input checked="" type="checkbox"/> TECHNICIAN
<input checked="" type="checkbox"/> SERVICE ADVISOR	<input checked="" type="checkbox"/> SERVICE MANAGER	<input checked="" type="checkbox"/> WARRANTY PROCESSOR	<input checked="" type="checkbox"/> SALES MANAGER

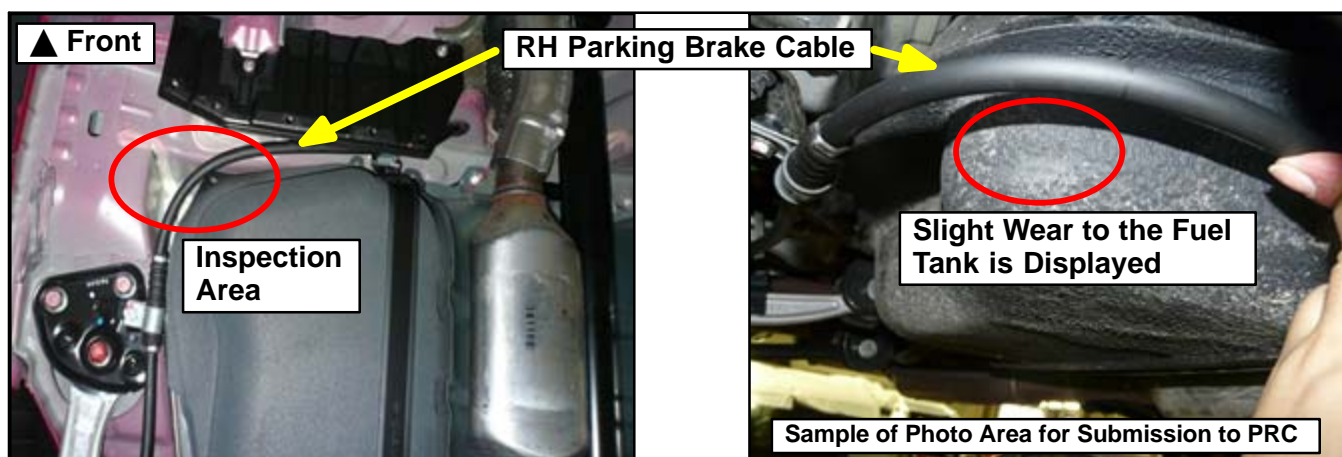
1. Place the vehicle on a lift. Set the gear selector to “P” (Park) in TC-SST equipped vehicles or place the transmission in gear for manual transmission equipped vehicles. **Do not engage the parking brake.**
2. Lift the vehicle and inspect the coating on the fuel tank’s front right corner for damage or wear.

!! IMPORTANT !! Since the parking brake cable may have less tension when the parking brake is engaged, there may be a gap between the fuel tank and the right parking brake cable. Carefully inspect the right parking brake cable and the coating on the fuel tank for damage or wear.

3. Upload photographs of the front right corner of the fuel tank to the Photo Required Condition System (PRC). See sample of area to be photographed above.
4. Lower the vehicle. If TC-SST equipped, place the gear selector to “N” (Neutral).

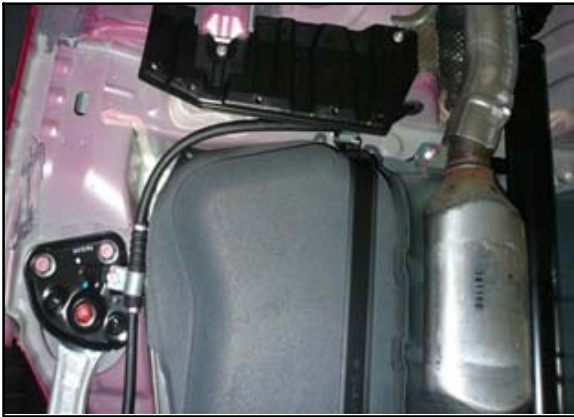
19. Lift the vehicle. Ensure there is sufficient gap between the fuel tank and right parking brake cable.

20. Refer to Step 12 and torque the right parking brake cable bolts to specification.
