## HEHR INTERNATIONAL INC.

### NHTSA Recall RC-15V553

#### **Field Inspection Process / Verification Checklist**

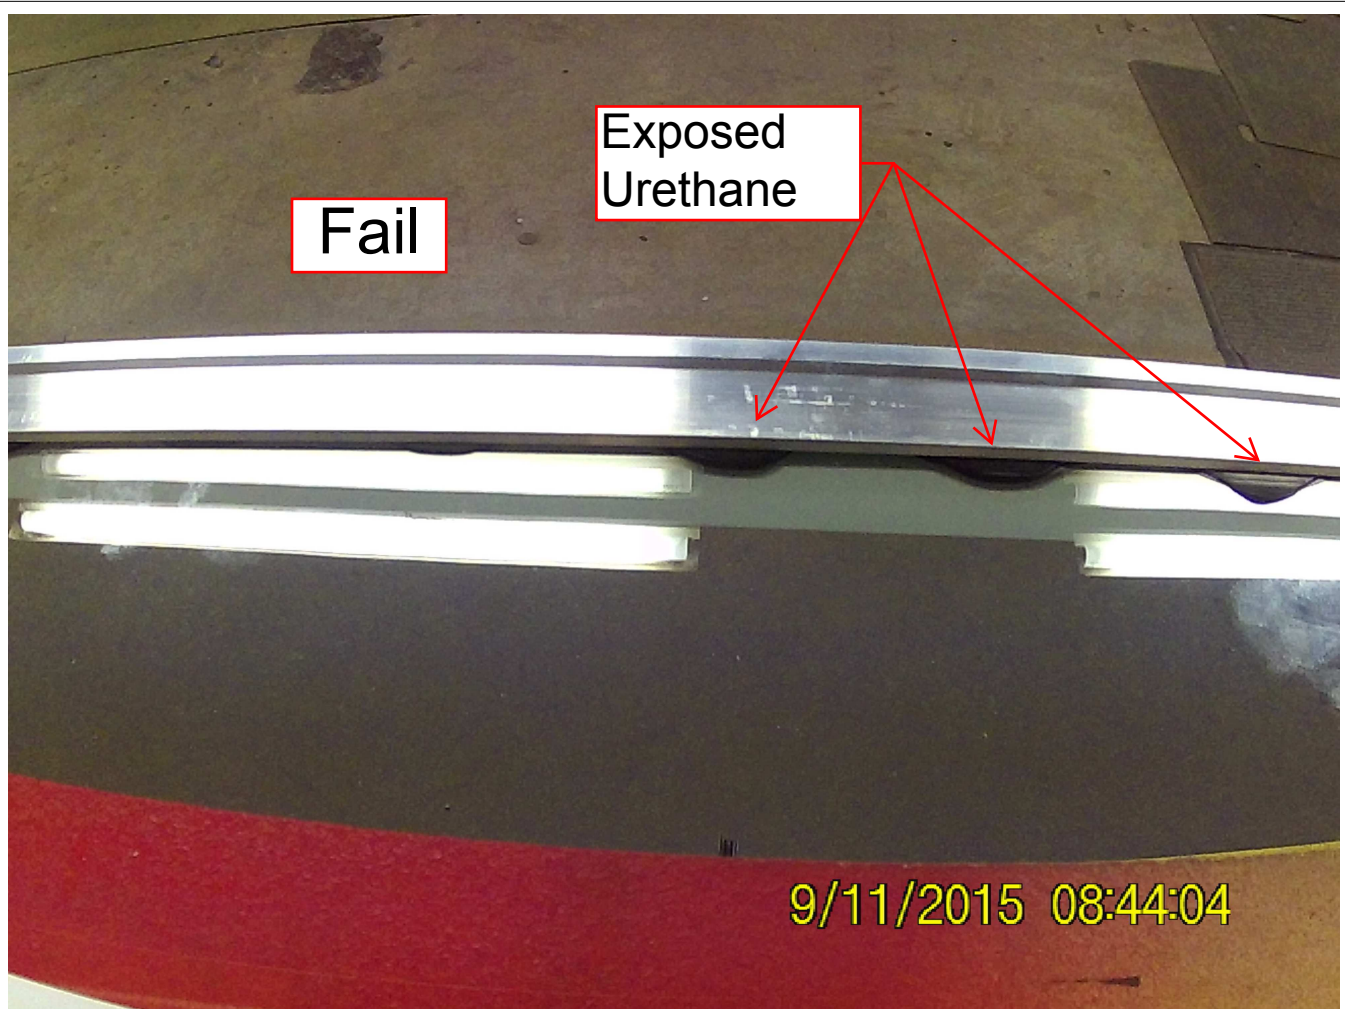
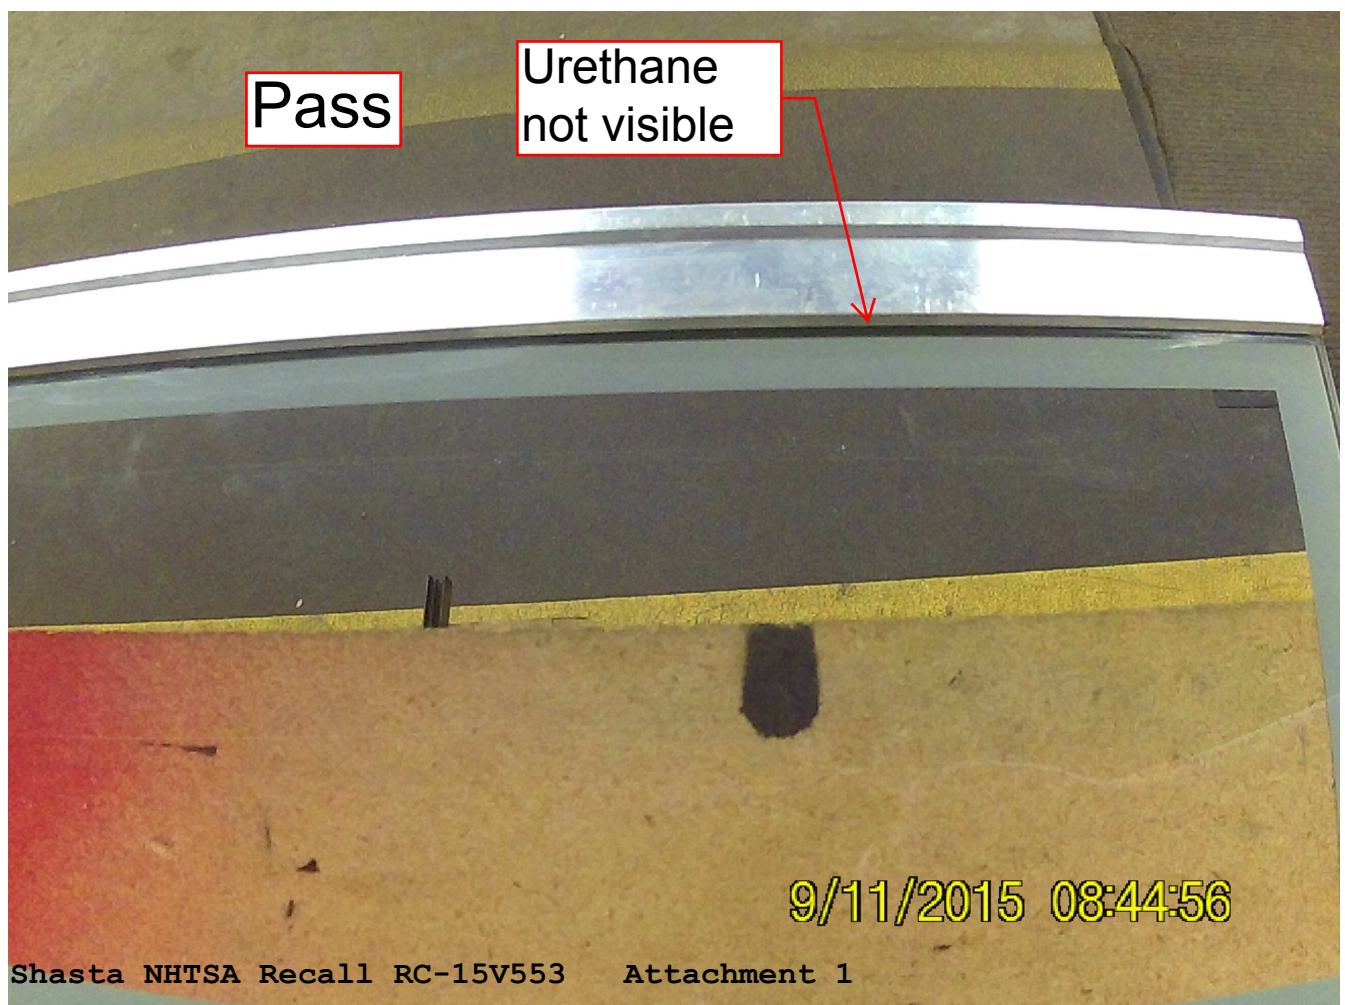
1. Record the unit's VIN number → \_\_\_\_\_
2. VISUAL OBSERVATION OF BOND AREA (*Attachment #1*)  
☐ **Pass**   ☐ **Fail**   ☐ **N/A**
  - 2.1. Look along the bottom edge of the hinge that is bonded to the glass across the top of the pivot assembly. If the following condition exists, this step is considered a "Fail" and no further testing is required.

- 2.1.1. More than  $\frac{1}{16}$ " of urethane is visible below the bottom edge of the hinge.
3. EXCESSIVE HINGE / GLASS GAP (*Attachment #2*)  
☐ **Pass**   ☐ **Fail**   ☐ **N/A**
