14130 Version 4

Safety Recall: Ignition Coils

Supersedes 15-060, dated June 23, 2018, to revise the information highlighted in **yellow**.

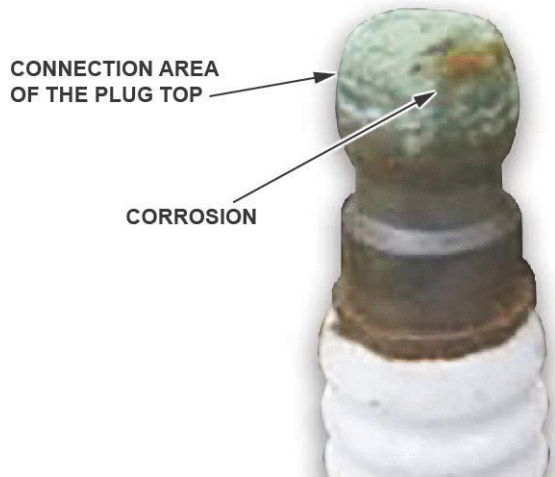
4. Inspect the connection end of the spark plugs.

- If the spark plug connection ends have corrosion on them, clean them with a commercially available cleaner, then reinstall the spark plugs and torque them to **22 N·m (16 lb-ft)**.
 - If the spark plug connection ends does not have any corrosion on them, reinstall the spark plugs and torque them to **22 N·m (16 lb-ft)**.
5. Install the new ignition coils and torque them to **12 N·m (9 lb-ft)**.
6. *California residents only.* Fill out a Vehicle Emissions Recall – Proof of Correction certificate, and use JT9 as the recall number. Give the certificate to your customer, and advise him or her to keep it as proof that the recall was completed. Your customer will need to submit this certificate to the DMV only if the DMV requests it. If you need more certificates, use reorder number Y0657.
