Service Bulletin

15-060

Safety Recall: Ignition Coils

Year	Model	Trim	VIN Range	
2015	Fit	ALL	Check the iN VIN status for eligibility

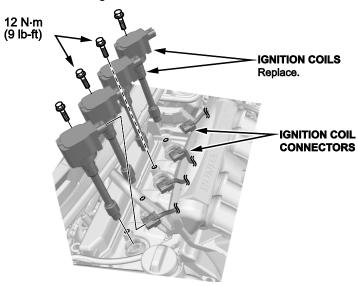
1. Disconnect the ignition coil connectors.

- 2. Remove the ignition coils.
- 3. Remove the spark plugs.
