Technical Service Bulletin

GROUP	NUMBER
RECALL	15-01-033
DATE	MODEL(S)
SEPT 2015	ACCENT (MC)

SUBJECT: STOP LAMP SWITCH REPLACEMENT (RECALL 131)

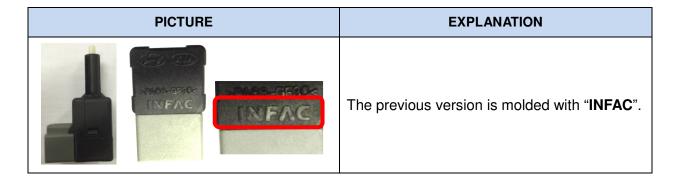
For vehicles under this recall, never install the previous version of the stop lamp switch. Refer to the picture in the table below.

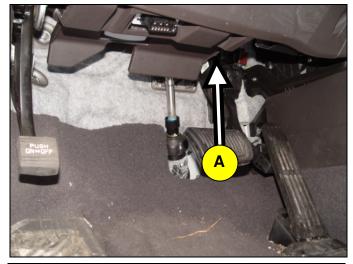
Locate the stop lamp switch (A) above the brake pedal assembly.

1. Disconnect the stop lamp switch connector (A).
