**HYUNDAI**NEW THINKING.
NEW POSSIBILITIES.**Technical Service Bulletin**

17-01-016

ACCENT (MC)**SUBJECT: STOP LAMP SWITCH REPLACEMENT (RECALL 131)***This TSB supersedes TSB# 15-01-033 to revise the service procedure to clarify the superseded part installation.***★ IMPORTANT******* Retail Vehicles *****

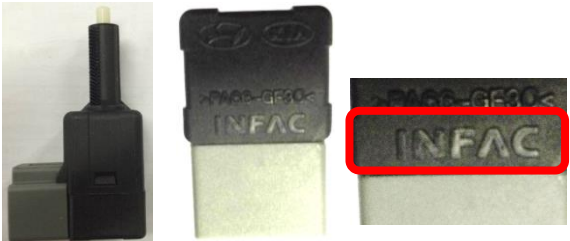
PICTURE	EXPLANATION

For vehicles under this recall, never install the previous version of the stop lamp switch. Refer to the picture in the table below.

The previous version is molded with "INFAC".

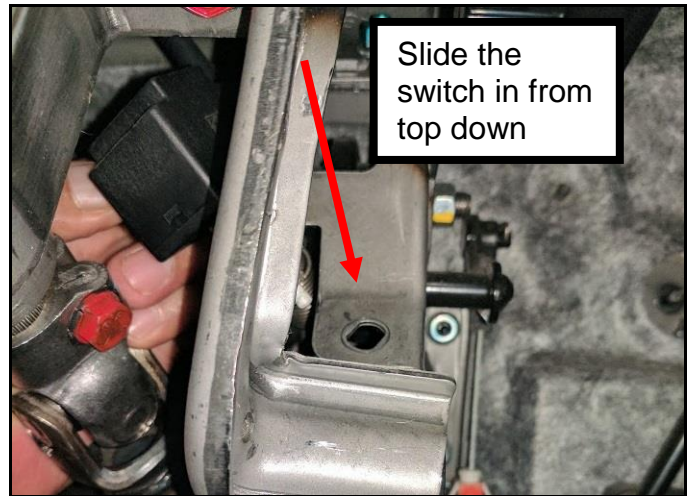
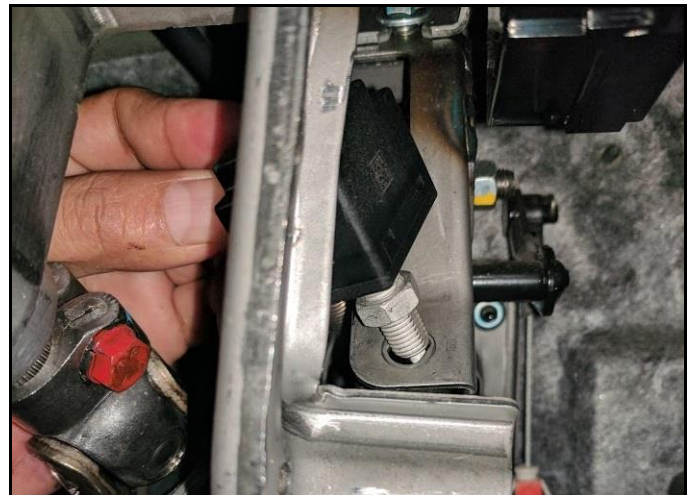
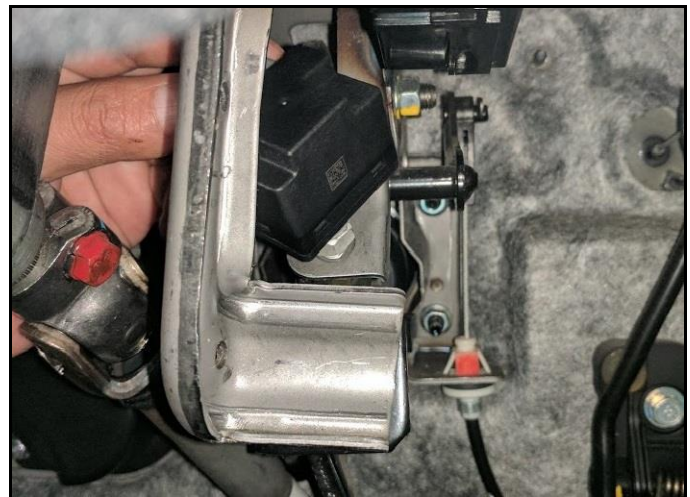
For **non-cruise** control equipped vehicles, it may be slightly difficult to install the superseded switch due to space limitation.

1. Grab the stop lamp switch by the connector side with the switch facing downward and place hand behind the steering column.
2. Slide the switch from top to downward and place the switch into the mounting bracket port.
