# SAFETY RECALL BULLETIN

SUBJECT: <b>SRS WARNING LIGHT ILLUMINATES – SAFETY RECALL CAMPAIGN</b>			No: <b>SR-15-011</b>
			DATE: <b>October, 2015</b>
			MODEL: <b>2012 i-MiEV &amp; 2014 Mirage</b>
CIRCULATE TO:	<input checked="" type="checkbox"/> GENERAL MANAGER	<input checked="" type="checkbox"/> PARTS MANAGER	<input checked="" type="checkbox"/> TECHNICIAN
<input checked="" type="checkbox"/> SERVICE ADVISOR	<input checked="" type="checkbox"/> SERVICE MANAGER	<input checked="" type="checkbox"/> WARRANTY PROCESSOR	<input checked="" type="checkbox"/> SALES MANAGER

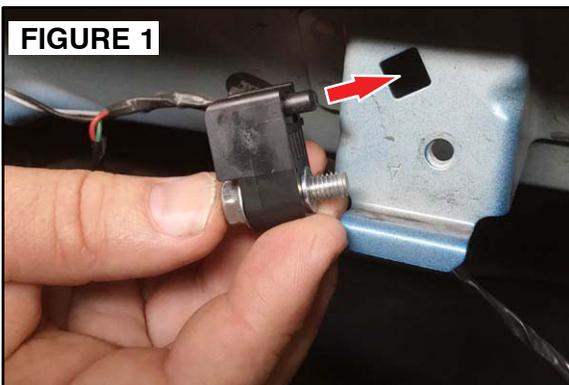
**FIGURE 1**

There is a tab located on the back of the impact sensor that slots into the mounting surface. To ensure proper installation, make sure the tab is inserted into the slot on the mounting surface as shown.

(2014 Mirage front impact sensor shown as example.)
