### PRODUCT SAFETY RECALL

SUBJECT: Windshield Wiper Motor Failure

#### MODELS: 2016 Buick Enclave 2016 Chevrolet Traverse 2016 GMC Acadia

GM Recall #15780

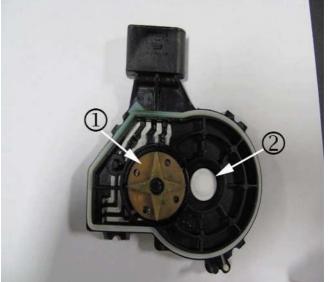
4282670

Caution: Damage may occur to the part if the sprocket is not aligned properly.

6. On the new wiper cover, align the sprocket (1) with the breather (2) as shown in the picture above.
